Condition Assessment Report (CAR)

Druid Hills Railroad Bridge

DeKalb County, Georgia

August 4, 2020

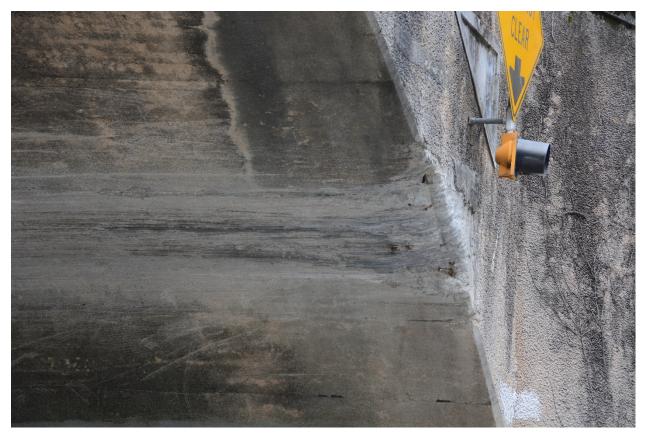
One of the most significant deficiencies observed with the bridge is damage to the arch ring caused by collisions with vehicles. Exposed reinforcement rod at the damaged arch ring facing west is missing a section and the exposed ends are bent and rusting. Damage in the form of deeply etched furrows in the concrete extends beyond the arch ring along the face of the barrel following the flow of traffic.

Figure 8: Detail of underside of bridge (barrel and arch ring) showing damage from vehicle impact.

- Repair damage from vehicle impact. Remove failing and deteriorated concrete from around reinforcement bar on both the east and west facing arch rings. Remove bent and damaged portions of rusting reinforcement rod and weld in new reinforcement. Repair concrete in-kind using mix ratios determined from material sampling.

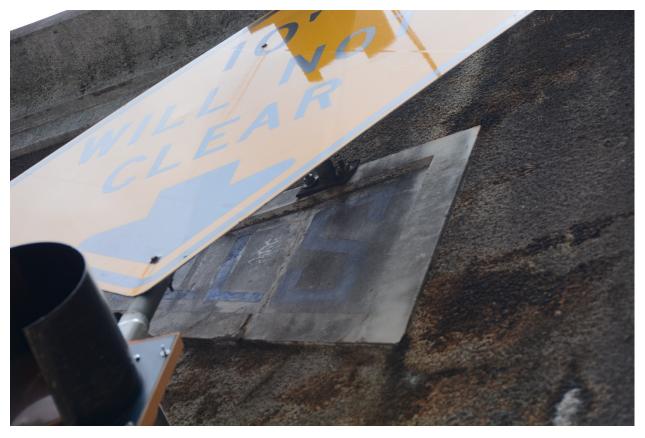
In attempts to reduce crashes with the bridge, signage warns drivers of the low-clearance condition. Signs extend down the roadway, but several, including blinking hazard lights, are attached directly to the bridge. In some cases, the signs are attached to the decorative elements of the bridge, including one of the spandrel panels that reads "Hills".

Figure 9: Detail of signage attached to and obscuring a decorative spandrel panel.

- Remove signage from bridge. As a rare example of a decorated reinforced concrete bridge, the signage obscuring the decoration has a significant negative impact on the ability to view and appreciate the decoration. Signage should be relocated away from bridge. If this is not possible, a less desirable alternative would be to attach signage in a way that avoids impacting or obscuring the decorative features.

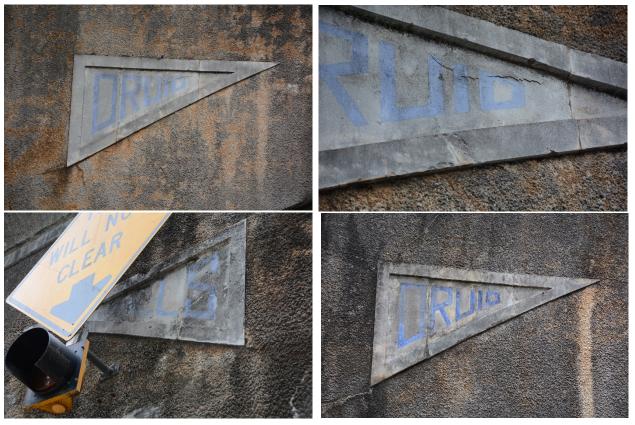
Figure 12: Details of triangular spandrel panels, clockwise from top-left: northwest spandrel panel, detail of area of potential spall on northwest panel, southeast panel, and northeast panel. Southwest panel is shown in Figure 9.

The decorative, triangular spandrel panels reflect similar conditions to other features of the bridge, but as one of the bridge's most distinctive features, it is worth noting several specific concerns. The lowrelief borders of all panels exhibit chipping at edges and the joints between pre-cast elements. The northwest panel has a plate fracture, possibly caused by a rusting anchor. This area is in danger of spalling off. The northeast and southwest panels have both been damaged by the installation of bolted anchors and armature to mount roadway signs. Generally, the paint is weathered, but readable. A closer analysis by a specialist would determine if the words were hand-painted or stenciled.

- Carefully clean and repair the triangular spandrel panels. Repair larger chips with an appropriately formulated repair mortar. Small chips not visible from the sidewalk should be left as is unless in danger of enlarging. As with other concrete features, some repair areas may require preparation for repair that includes tooling the damaged area to create a sound surface and applying a consolidant and/or adhesive to the repair area. The fracture on the northwest panel may require removal of concrete material to remove and replace a rusting anchor and to prepare the area for a repair patch. Tuck point missing or deteriorated mortar using an in-kind formulation derived from material analysis. Repaint the Druid Hills lettering using a high-quality exterior paint formulated for concrete and in a similar technique as the original (e.g. hand-painting or stenciling). Consider applying a protective and reversible clear coating over the original paint and as well over the restored lettering to protect the features and to help with keeping them clean.
