CORRIDOR Road Safety Audit

SR 8 / SR 10 / US 23 / US 29 / US 78 / US 278 /
PONCE DE LEON AVENUE NE / SCOTT BOULEVARD
ATLANTA AND DECATUR | DEKALB COUNTY | GEORGIA

Prepared for the Georgia Department of Transportation

December 2015

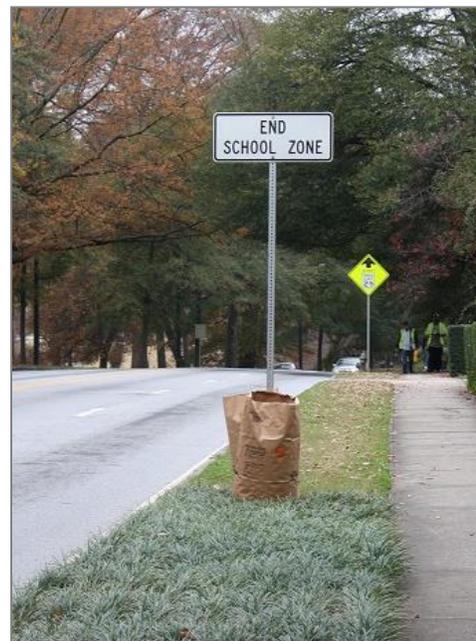
FIGURE 2-4. A MISPLACED SIGN INDICATES THE END OF A SCHOOL ZONE AND ANOTHER ADVISES DRIVERS OF A SCHOOL ZONE FURTHER WEST FOR SPRINGDALE PARK ELEMENTARY.

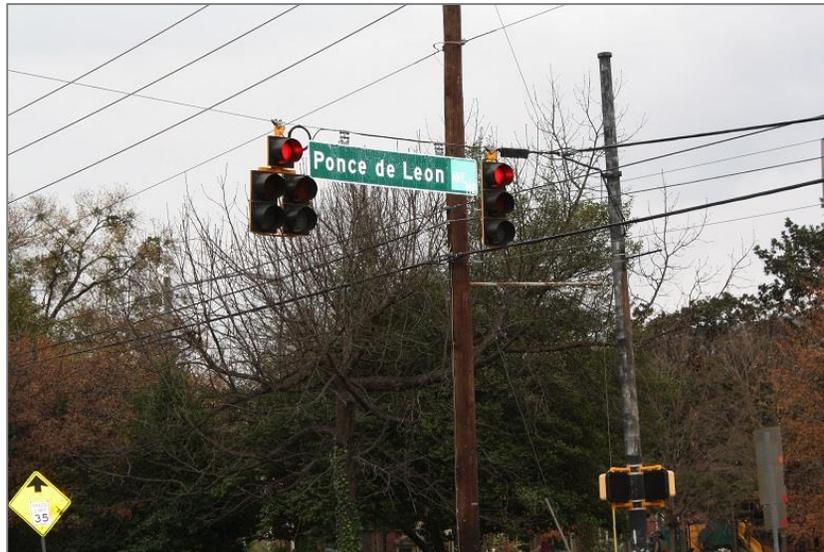
FIGURE 5-1. TYPICAL SIGNAGE AND SIGNALS THROUGHOUT THE CORRIDOR. SOME SIGNALS ARE MISSING REFLECTIVE BACKPLATES AND SOME STREET NAME SIGNS ARE OUTDATED OR DAMAGED

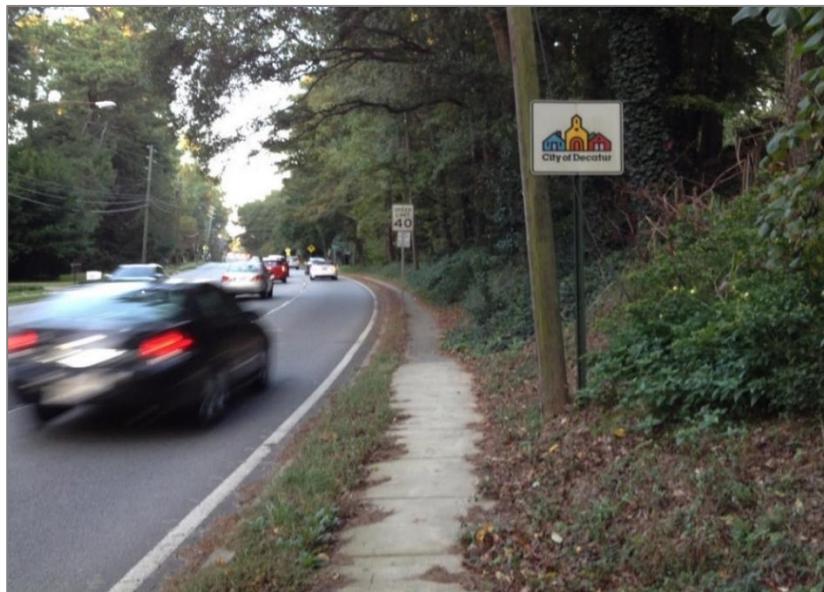
FIGURE 5-2. AN EXAMPLE OF TYPICAL SIDEWALK CONDITIONS ALONG SCOTT BOULEVARD.

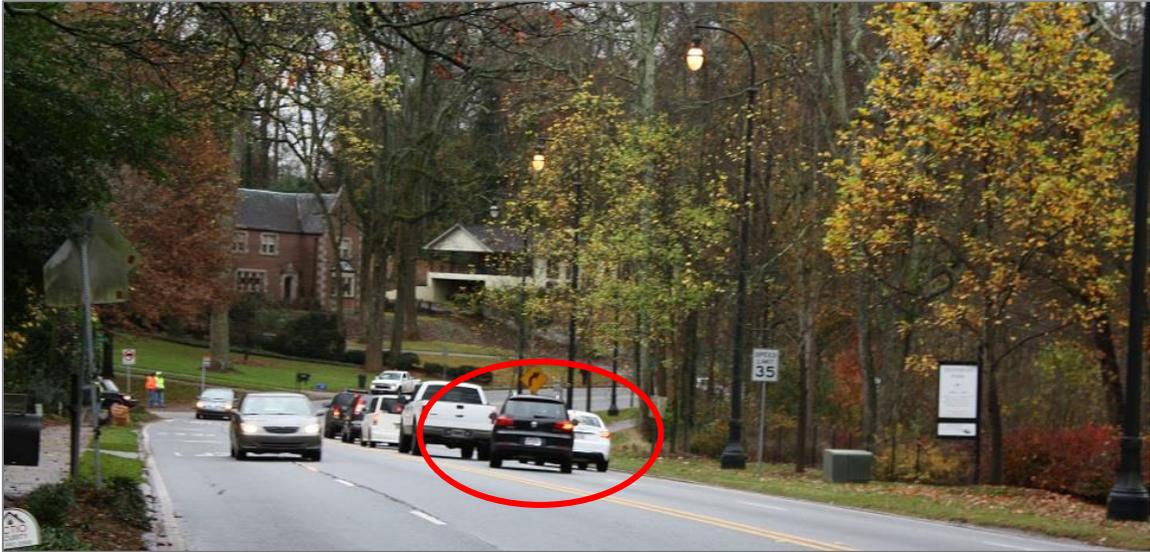
FIGURE 5-3. AN EXAMPLE OF VEHICLES MERGING TO AVOID LEFT TURNING TRAFFIC ALONG THE CORRIDOR (IN THIS CASE AT RIDGECREST ROAD).

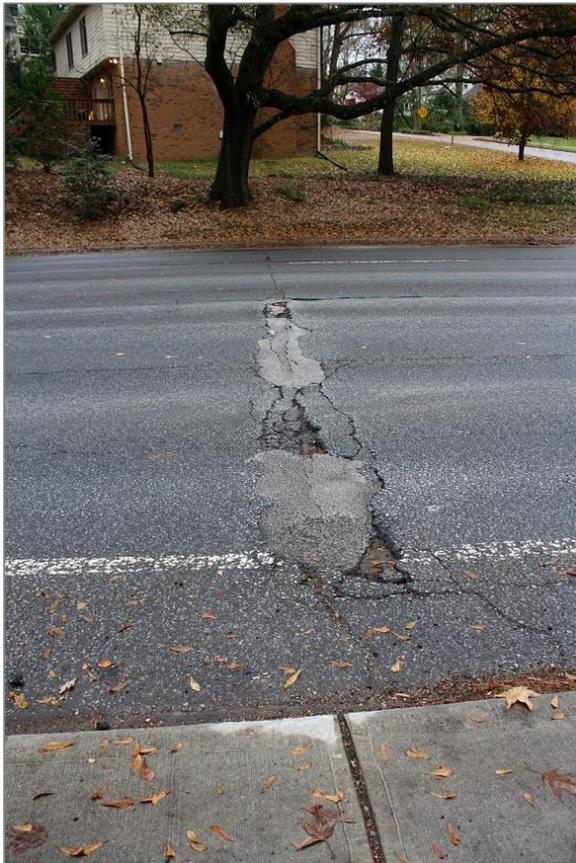
FIGURE 5-5. ROADWAY PAVEMENT IN NEED OF REPAIR ON SCOTT BOULEVARD NEAR NELSON FERRY ROAD.

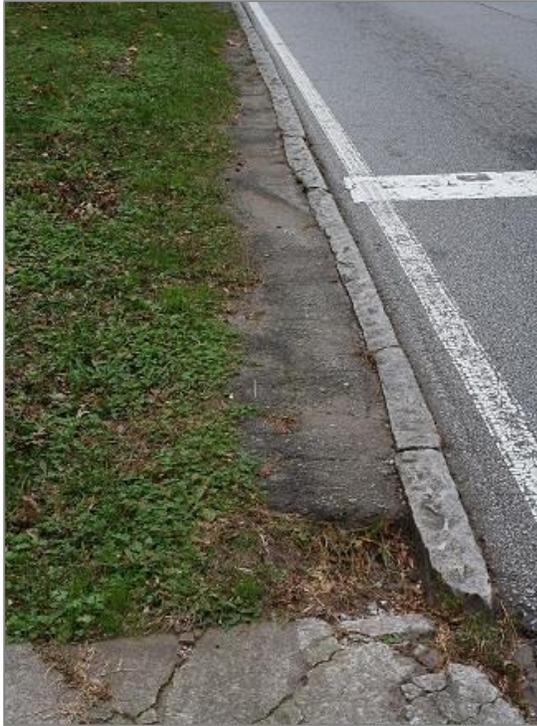
FIGURE 5-7. DAMAGE TO THE HISTORIC GRANITE CURB.

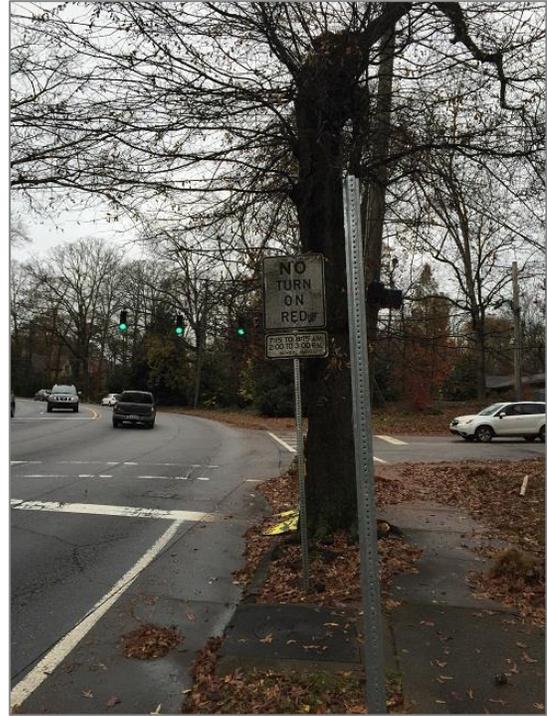
FIGURE 5-8. DIRTY AND DAMAGED SIGNS.

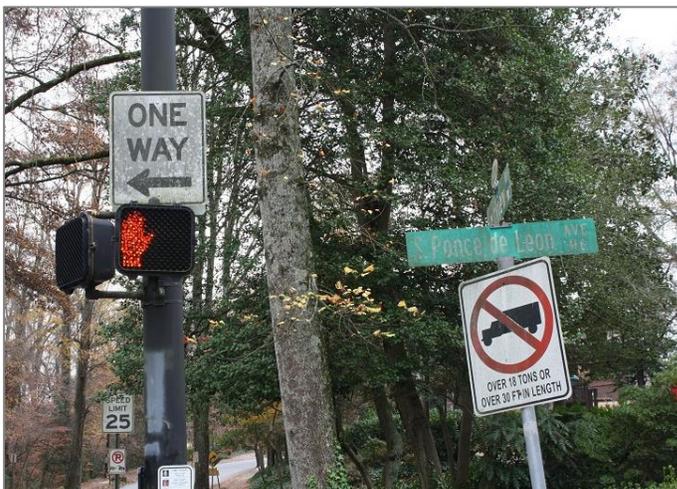
FIGURE 5-13. WORN SIGNS AT THE INTERSECTION OF SOUTH PONCE DE LEON AVENUE AND FAIRVIEW ROAD.

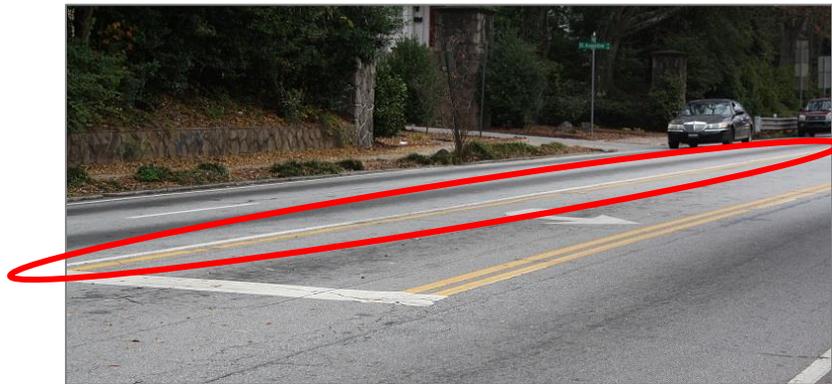
1. **Sidewalk is not present on the south** side of Ponce de Leon Avenue NE, just past South Ponce de Leon Avenue NE.
2. There is an **extra double yellow line** on Briarcliff Road/SR 42 just north of Ponce de Leon Avenue NE.
3. The **left turn lane** from westbound Ponce de Leon Avenue NE to southbound Moreland Avenue/US 23 is **too short** to accommodate all turning vehicles.
4. **Pedestrian equipment**, including signal poles, pedestrian push buttons, pedestrian ramps, and truncated domes, **do not meet current standards**.
5. The audit team observed **heavy traffic volumes** for the current configuration of the intersection.
6. The **left turn signal** was observed by the audit team to be very **short**, especially for vehicles turning from Moreland Avenue/US 23 to westbound Ponce de Leon Avenue NE.

FIGURE 5-17. EXTRA DOUBLE YELLOW LINE ON BRIARCLIFF ROAD/SR 42.

SAFETY BENEFIT	LEVEL OF EFFORT	TIME FRAME	COST
1. Remove the extra double yellow line on Briarcliff Road/SR 42.	Moderate	Low	Short Term	Low
2. Study signal timing for left turn movements and make adjustments as needed to reduce congestion on Moreland Avenue/US 23 and Briarcliff Road/SR 42.	Moderate	Low	Short Term	Low
3. Consider installing sidewalks or relocating paths through Olmsted Linear Park closer to road on south side of the corridor east of South Ponce de Leon Avenue NE. <i>This would be the purview of City of Atlanta and should be done in consultation with the Olmsted Linear Park Alliance.</i>	Low	Moderate	Intermediate	Moderate
4. Redesign intersection and implement full intersection improvement.	High	High	Long Term	High

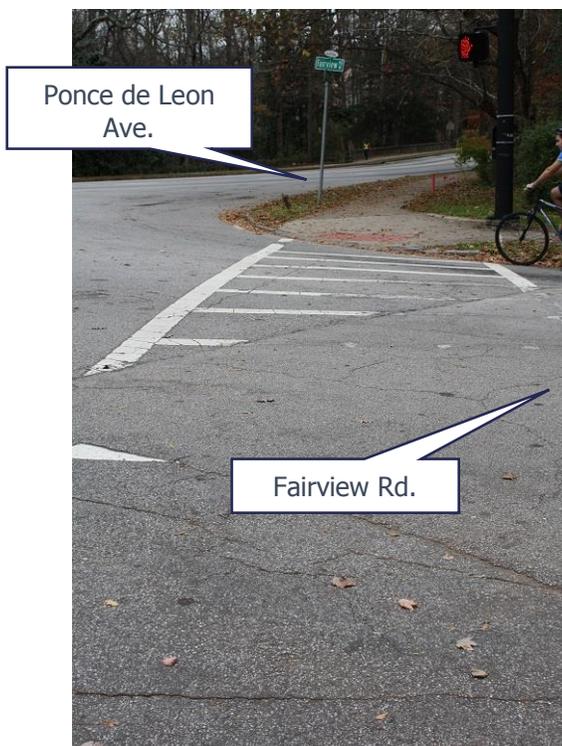
FIGURE 5-26. CROSSWALK IN NEED OF RESTRIPIING WHERE FAIRVIEW ROAD MEETS THE RSA CORRIDOR.

SAFETY BENEFIT	LEVEL OF EFFORT	TIME FRAME	COST
1. Refresh and install crosswalks as needed, including on east side.	High	Low	Short Term	Low
2. Carry out intersection improvement project (PI #0012824) and install working pedestrian push buttons.	High	Moderate	Intermediate	Moderate
3. Consider a recommendation from bicycle and pedestrian groups to raise the curb at intersection corners.	Moderate	Low	Intermediate	Low
4. Install a guardrail along the bridge on Ponce de Leon Avenue NE.	High	Low	Intermediate	Moderate
5. Install more "No Turn on Red" signage.	High	Low	Short Term	Low

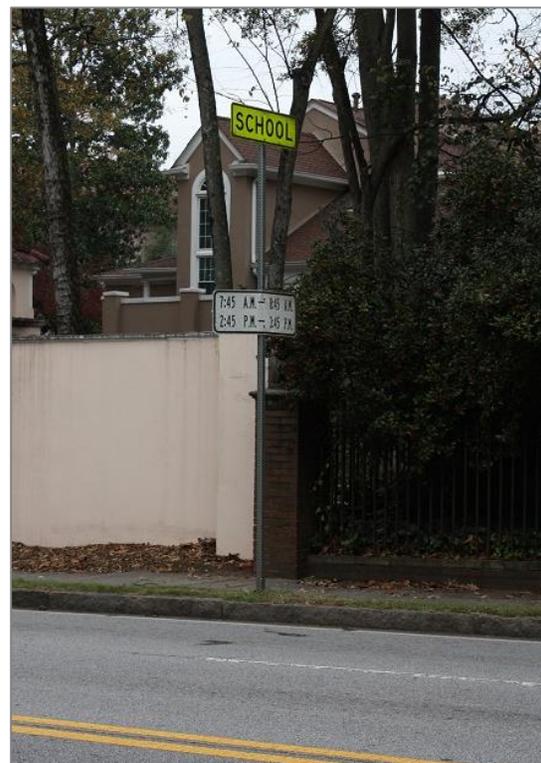
FIGURE 5-32. MISPLACED AND DAMAGED SCHOOL ZONE SIGN ON NORTH SIDE OF PONCE DE LEON AVENUE NE NEAR LULLWATER ESTATE.

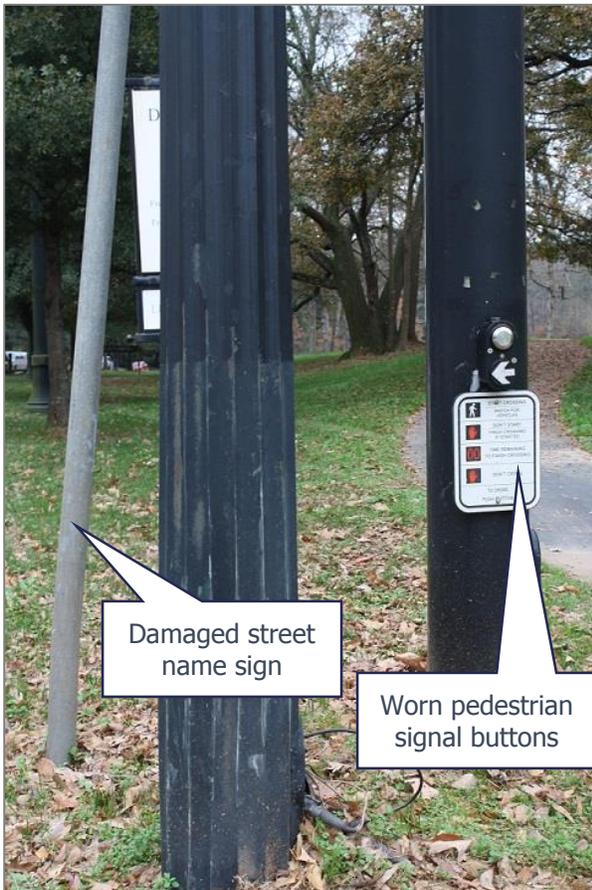
FIGURE 5-38. DAMAGED EQUIPMENT IN THE SOUTHEAST QUADRANT.

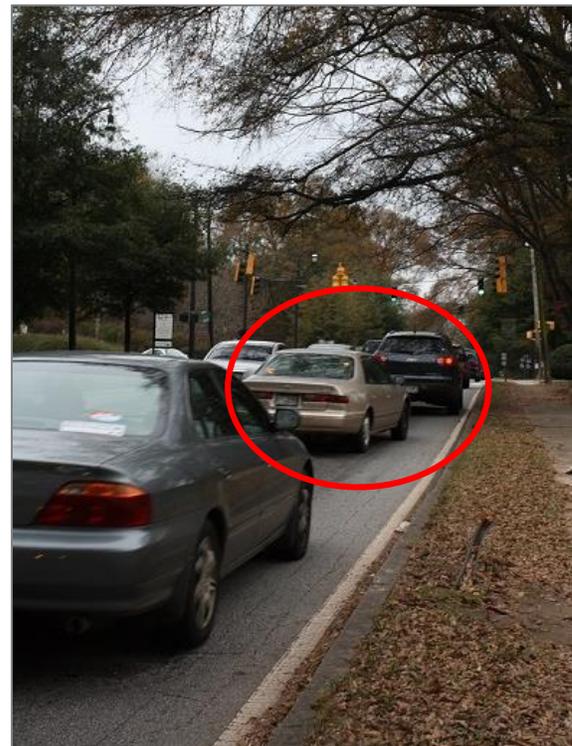
FIGURE 5-37. TRAFFIC APPROACHING CLIFTON ROAD. NOTE CAR PULLING AROUND TURNING VEHICLES AHEAD.

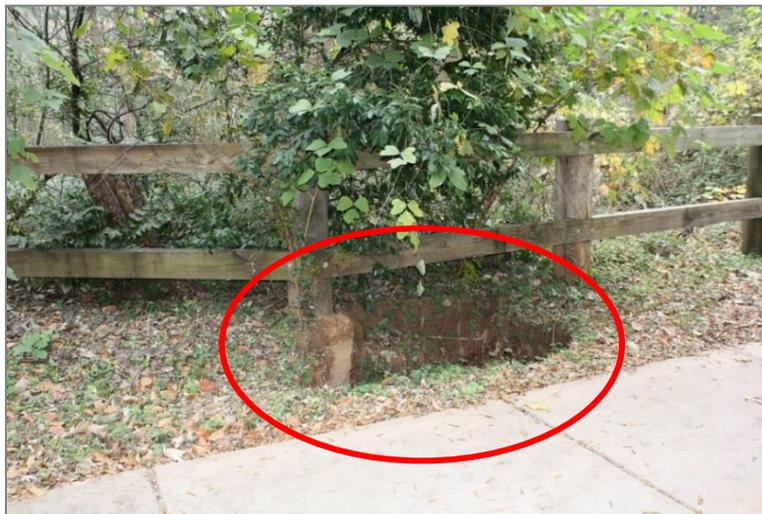
FIGURE 5-43. SINKHOLE AT CULVERT ON NORTH SIDE OF RSA CORRIDOR BETWEEN SOUTH PONCE DE LEON AVENUE AND NORTH PONCE DE LEON AVENUE.

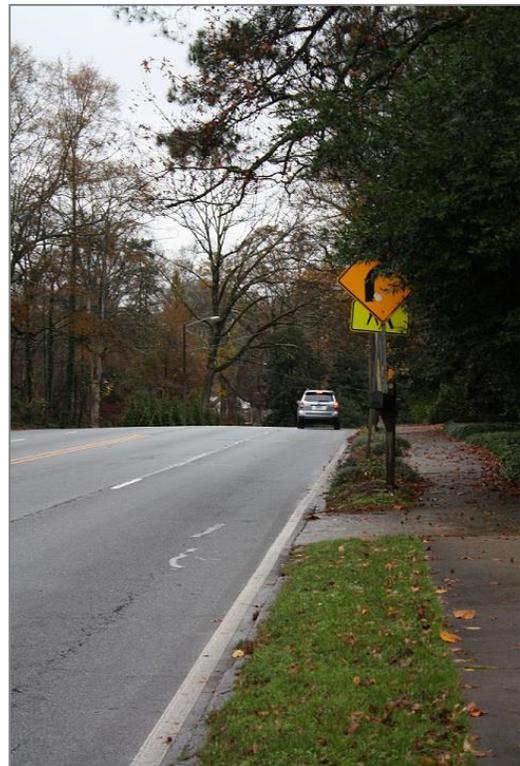
FIGURE 5-55. SIGNAGE BLOCKED BY VEGETATION.

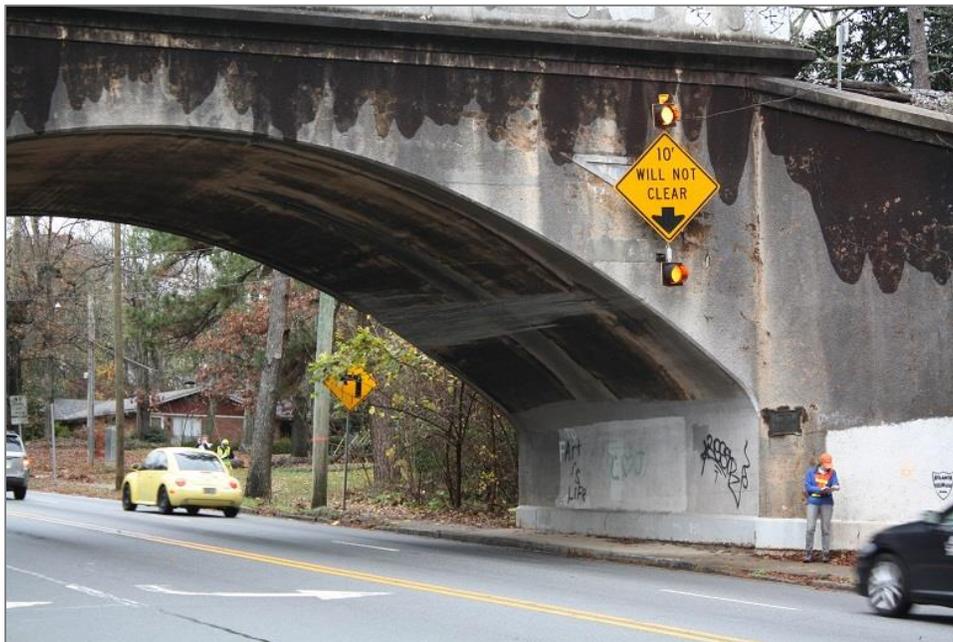
FIGURE 5-61. CSX RAILROAD BRIDGE. THIS SIGN, IN WESTBOUND LANES, IS CLEARER THAN OTHERS, BUT BY THE TIME MOTORISTS CAN SEE IT, IT MAY BE TOO LATE.

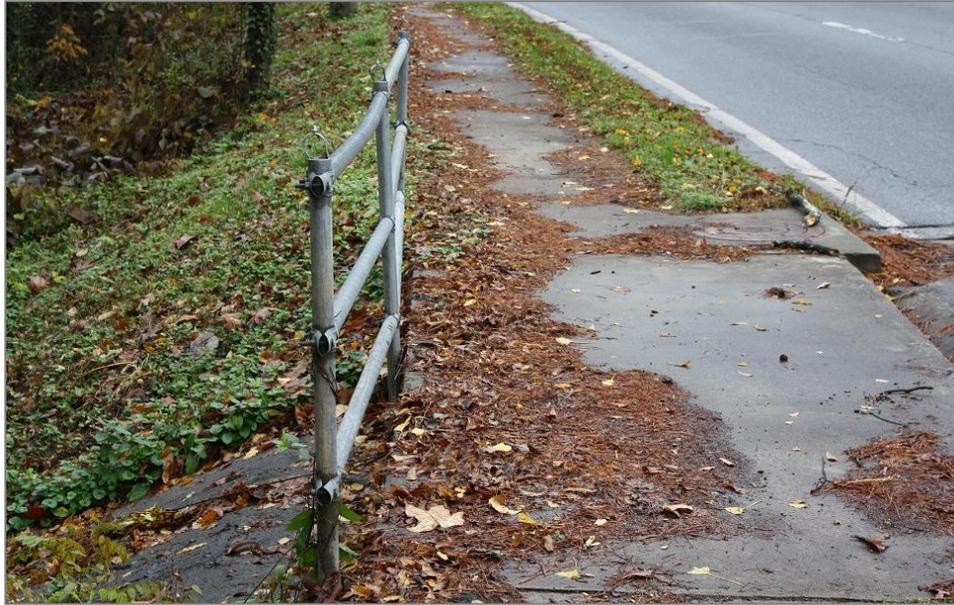
FIGURE 5-71. UNSUITABLE HANDRAIL ON SCOTT BOULEVARD, JUST NORTH OF NORTH PARKWOOD ROAD.

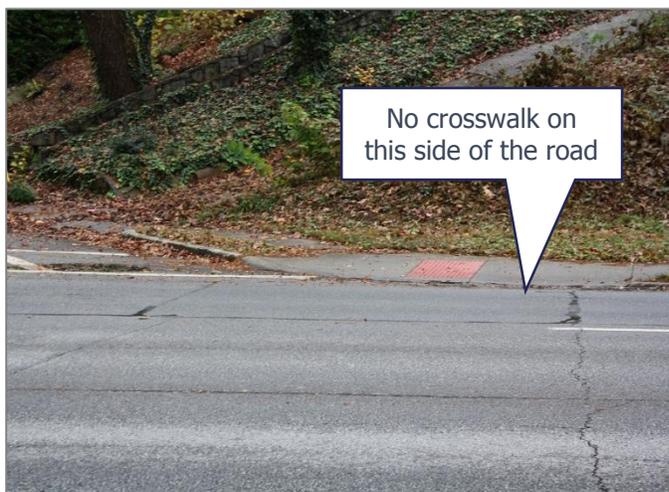
FIGURE 5-76. MISSING CROSSWALK AND IMPROPERLY ALIGNED CURB RAMP.

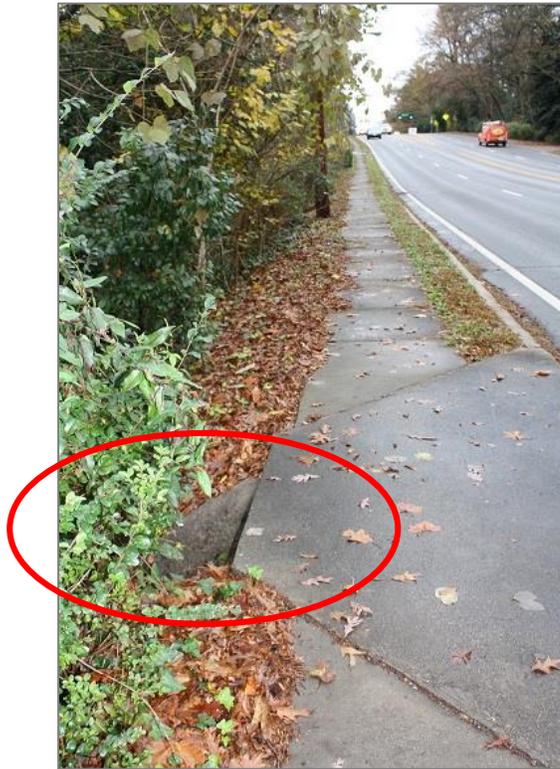
FIGURE 5-83. STEEP SLOPE AND DRAIN CULVERT ON WEST SIDE OF SCOTT BOULEVARD NORTH OF

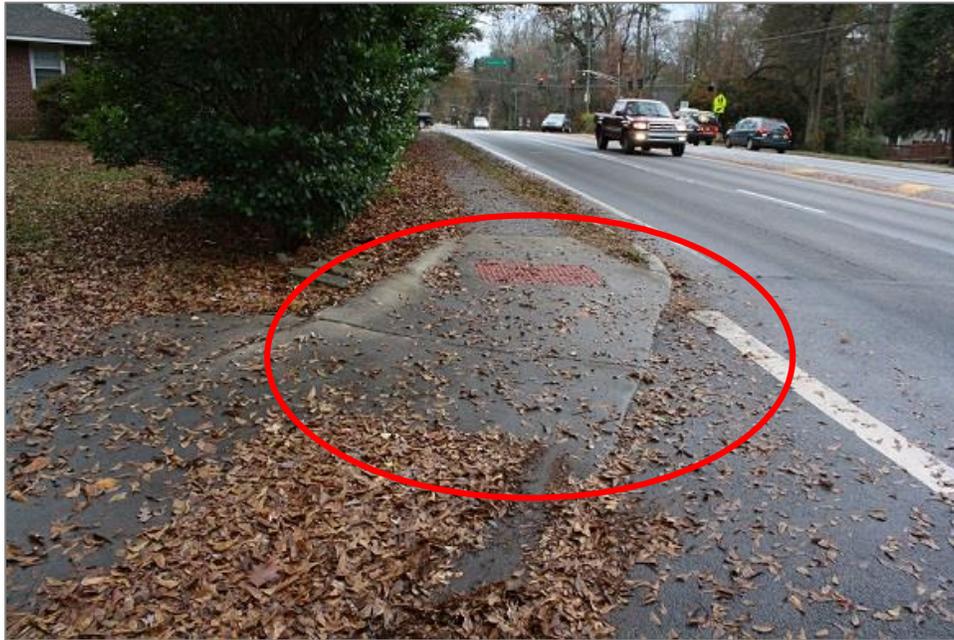
FIGURE 5-88. OFFSET PEDESTRIAN RAMP AND TRUNCATED DOMES AT LAMONT DRIVE.
