CORRIDOR Road Safety Audit

SR 8 / SR 10 / US 23 / US 29 / US 78 / US 278 /
PONCE DE LEON AVENUE NE / SCOTT BOULEVARD
ATLANTA AND DECATUR | DEKALB COUNTY | GEORGIA

Prepared for the Georgia Department of Transportation

December 2015

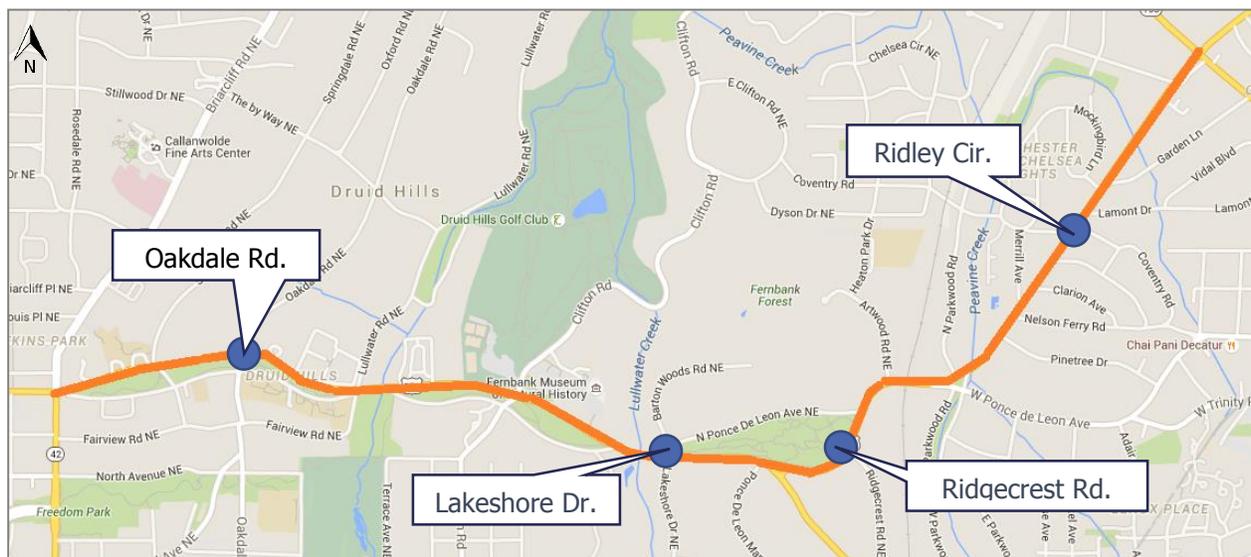
FIGURE 3-2. LOCATIONS OF FATAL CRASHES (2010-2015) (SOURCE: GDOT CRASH DATABASE)

Half of the fatal crashes were head-on collisions and half were angle crashes. The fatal crashes occurred at Ridgecrest Road, Lakeshore Drive, Oakdale Road, and Ridley Circle. A variety of factors were at play in these fatal crashes: the one at Ridgecrest Road was due in part to the driver losing control of the vehicle; the one at Lakeshore Drive was a D.U.I.; the one at Oakdale was a head-on collision involving a driver on the wrong side of the road; and the one at Ridley Circle involved a turning vehicle and failure to yield.

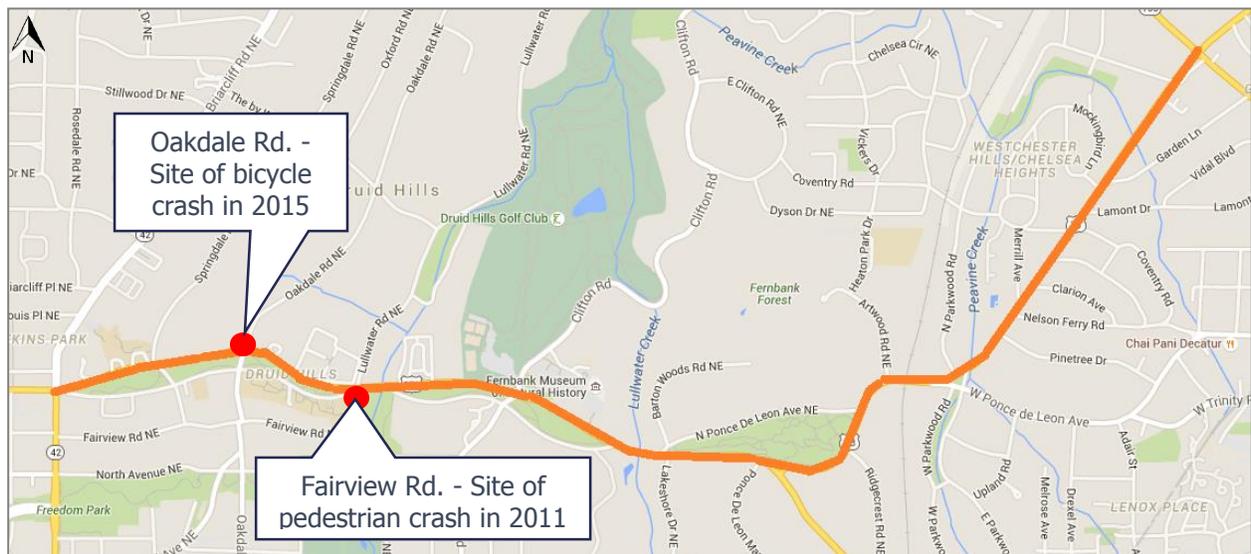
FIGURE 3-4. LOCATIONS OF PEDESTRIAN AND BICYCLE CRASHES 2010-2015

Overall, few bicycle and pedestrian crashes were recorded in the GDOT crash database. Only two crashes involved pedestrians and bicycles. The pedestrian crash occurred on Ponce de Leon Avenue NE at Fairview Road and the bicycle crash took place on Oakdale Road at Ponce de Leon Avenue NE. Neither of these were fatal.

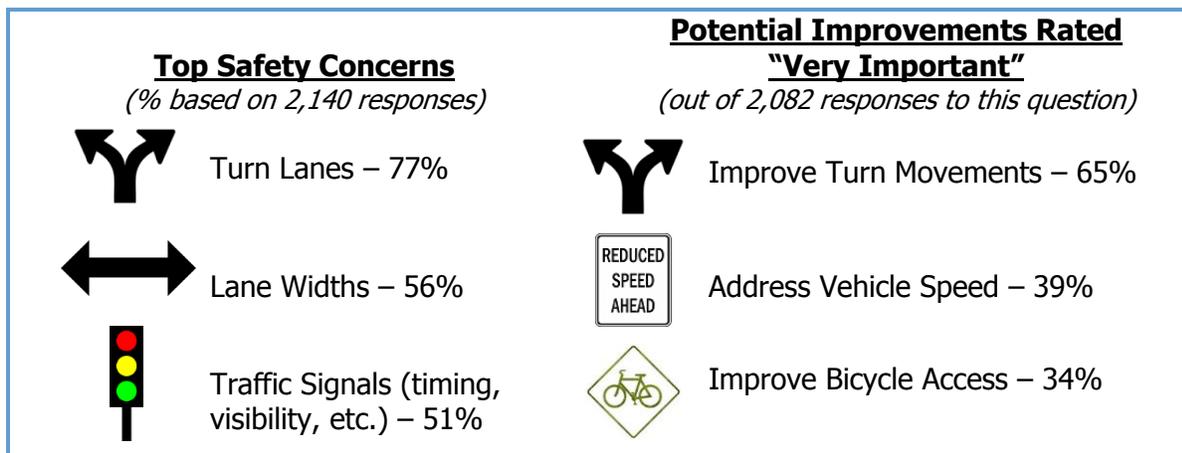
Moreland Avenue/US 23/Briarcliff Road/SR 42

Summary of Comments about Moreland Avenue/US 23/Briarcliff Road/SR 42: There is significant congestion on southbound Briarcliff Road/SR 42 as well as northbound Moreland Avenue/US 23 and the left turn signals are too short, adding to the congestion. The left turn lane from westbound Ponce de Leon Avenue onto southbound Moreland Avenue/US 23 is not long enough and traffic backs up into through lanes.

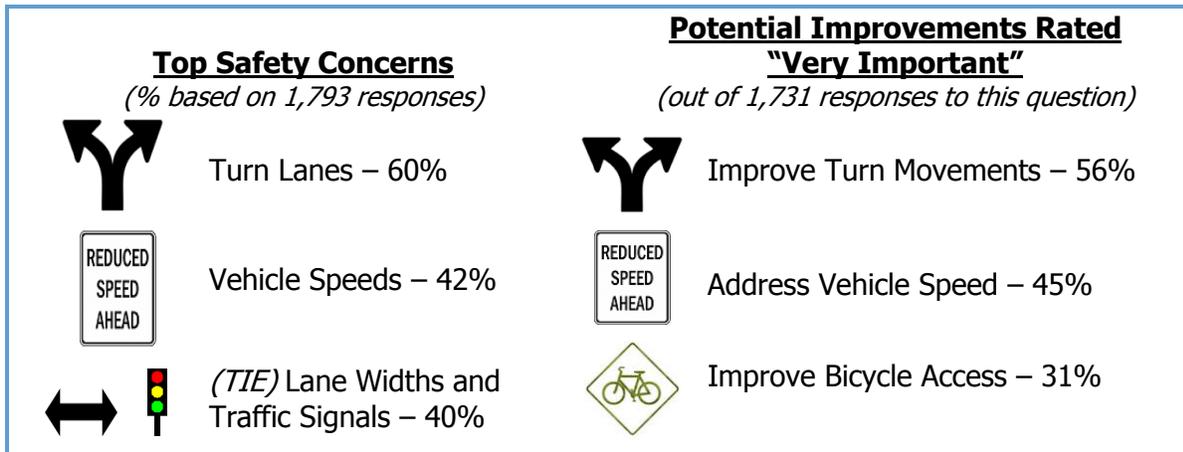
Summary of Comments about Springdale Road: It should be noted that among respondents who report that they live within one mile of the corridor, a slightly higher percentage view traffic signals (41%) at this intersection as a concern than they do lane widths (39%). Respondents are concerned about school traffic in this area – both in terms of creating congestion at pick-up and drop-off times, but also in terms of the number of pedestrians and their safety. Many comments report drivers pulling into adjacent lanes to bypass turning traffic, issues with drainage structures near the intersection, and drivers running red lights. It was also noted that Springdale is used as a cut-through for areas north and south of the corridor. Due to this increased volume of traffic and signal timing, Springdale Road experiences significant back-up, particularly in the evenings, as motorists wait to turn onto SR 8/SR 10/US 23/US 29/US 78/Ponce de Leon Avenue/Scott Boulevard.

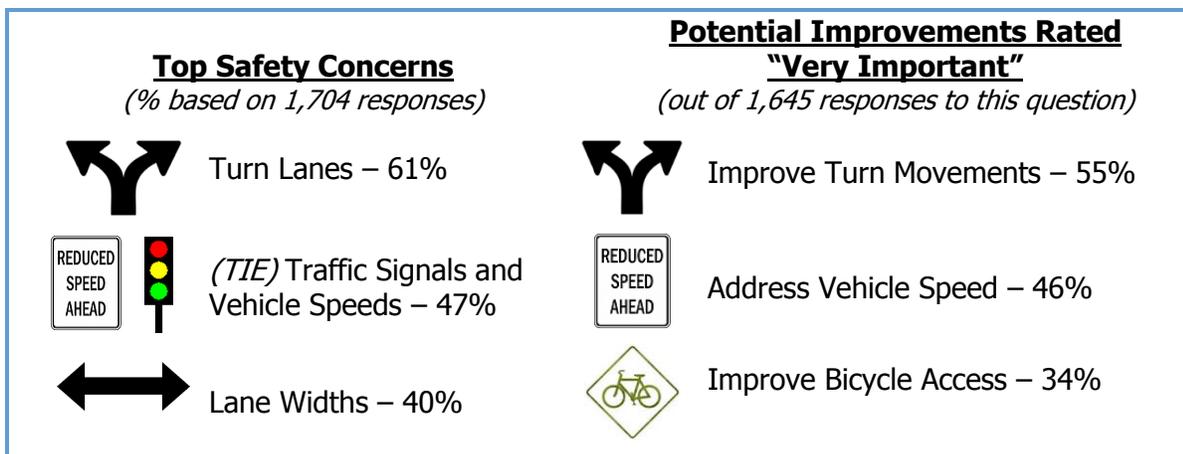
Lullwater Road/Fairview Road

Summary of Comments about Lullwater Road/Fairview Road: Overgrown vegetation blocks signs and drivers' views and the damaged drain grates are jarring to drivers. People are concerned about the length and timing of the signals and how traffic backs up and blocks the intersection at peak rush hours. Drivers reportedly ignore the "No Left Turn" sign on Fairview Road when traffic backs up. There are complications with the intersection of South Ponce de Leon Avenue

and drivers are sometimes confused about the signal cycle there. Several respondents would like to see more "No Turn on Red" signage from Fairview Road and there is a need for better connections for cyclists and pedestrians to area parks and paths. Slightly more area residents are concerned about vehicle speeds (48%) than traffic signals (47%).

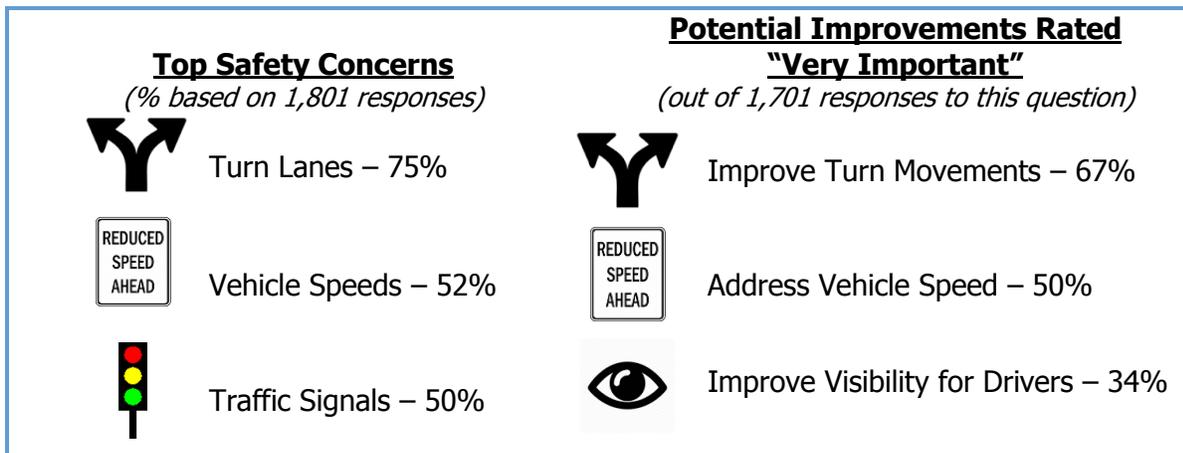
Summary of Comments about Clifton Road: Respondents noted a high number of crashes at this intersection, challenges with the left-turn movements and visibility from westbound Ponce de Leon Avenue turning onto southbound Clifton Road, and from southbound Clifton Road onto eastbound Ponce de Leon Avenue. There are concerns about the number of drivers who run red lights and exceed the speed limit when there is no congestion. Respondents noted that the left turn signals on Clifton Road have helped, but observe that on Ponce de Leon Avenue, drivers regularly pull into adjacent lanes to bypass left-turning traffic.

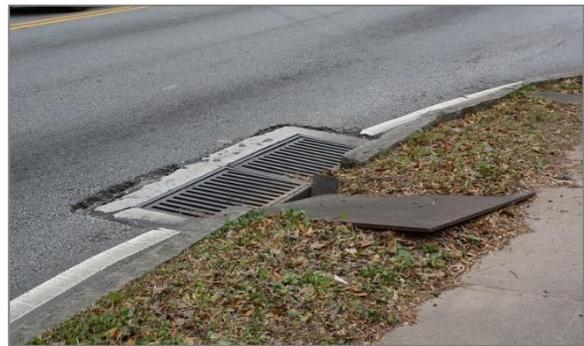
1. **Drainage structures** are damaged and many drains are blocked by debris. Drain grates are not level with the roadway surface.
2. **Street name signs** were found to be inconsistent throughout the corridor. Some were observed to be too small or missing.
3. Throughout the corridor, the audit team observed **dirty, worn, or faded signs**. Some signs are not reflective at night. Some "intersection ahead" signs are missing.
4. **Vegetation** was found to **block some signs, signals, and lights** throughout the corridor.
5. The **sidewalk** was observed to be in **marginal condition** throughout the corridor. Some segments are cracked or damaged, and in some areas the sidewalk is narrow and close to travel lanes. Some sections of the corridor were missing sidewalk altogether.

FIGURE 5-4. DAMAGED DRAIN STRUCTURES.

SAFETY BENEFIT	LEVEL OF EFFORT	TIME FRAME	COST
1. Complete programmed drainage project (PI #0010474) and repair or replace drainage structures as needed.	High	High	Intermediate	High

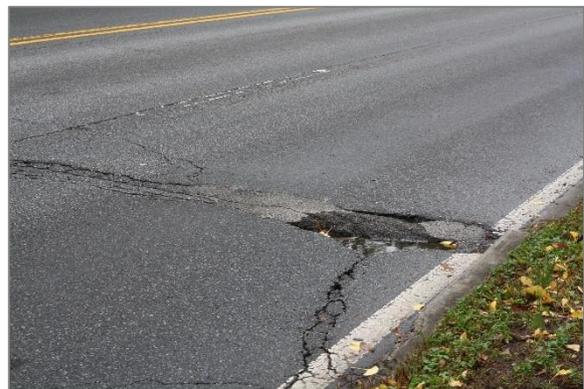
8. The audit team observed **cracks and potholes** throughout the corridor.
9. SR 8/SR 10/US 23/US 29/US 78/US 278/Ponce de Leon Avenue NE/Scott Boulevard has many curves. In some sections, the audit team observed that **signage alerting motorists about the curves is not present or missing**.

FIGURE 5-6. EXAMPLE OF ROADWAY IN NEED OF REPAIR ALONG RSA CORRIDOR.

8. Repair pavement or roadway surface as needed.	High	High	Intermediate	Moderate
9. Install "No Trucks" signs on side streets.	Moderate	Low	Short Term	Low

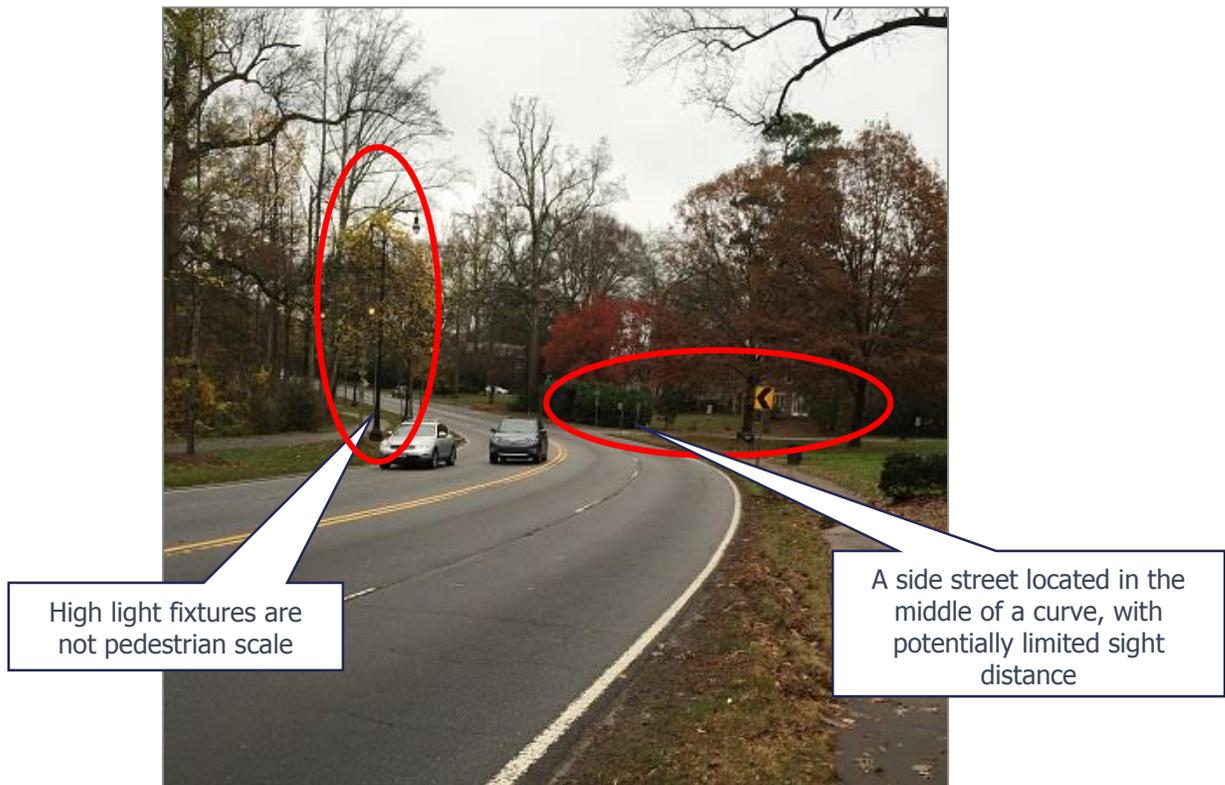
FIGURE 5-9. EXAMPLE OF CURVILINEAR NATURE OF SR 8/SR 10/US 23/US 29/US 78/US 278/PONCE DE LEON AVENUE NE/SCOTT BOULEVARD.

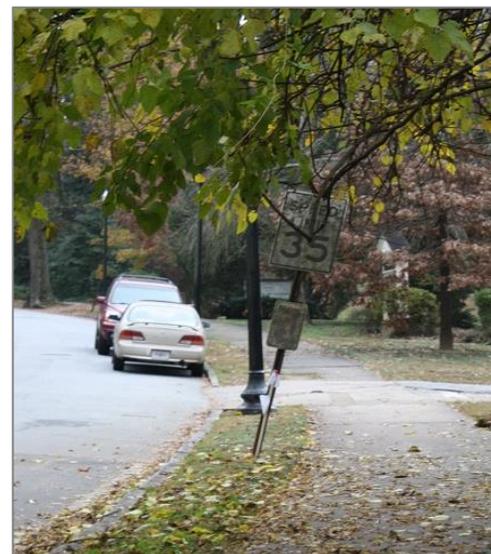
FIGURE 5-14. WORN, DAMAGED SIGNS ON SOUTH PONCE DE LEON AVENUE.

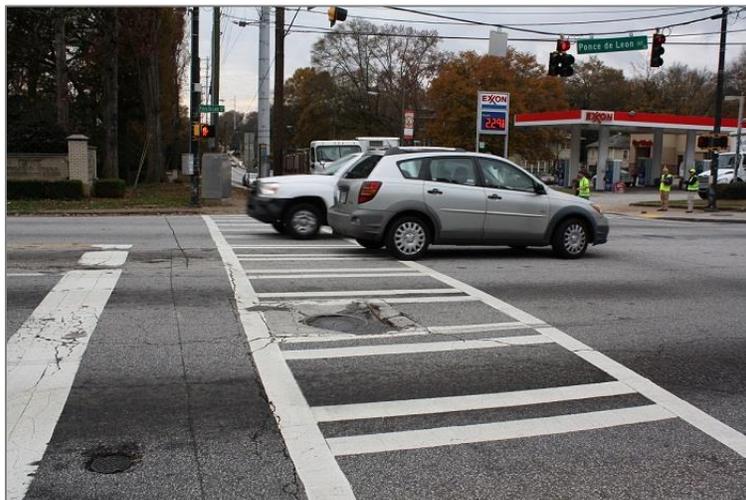
FIGURE 5-18. VIEW OF INTERSECTION AT MORELAND AVENUE/US 23/BRIARCLIFF ROAD/SR 42 FROM NORTHEAST CORNER.

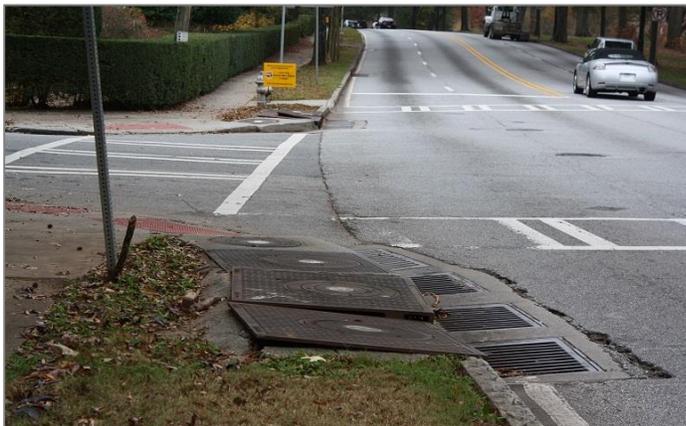
FIGURE 5-21. DRAIN STRUCTURES IN NORTH QUADRANTS OF INTERSECTION AT SPRINGDALE ROAD IN NEED OF REPAIR.

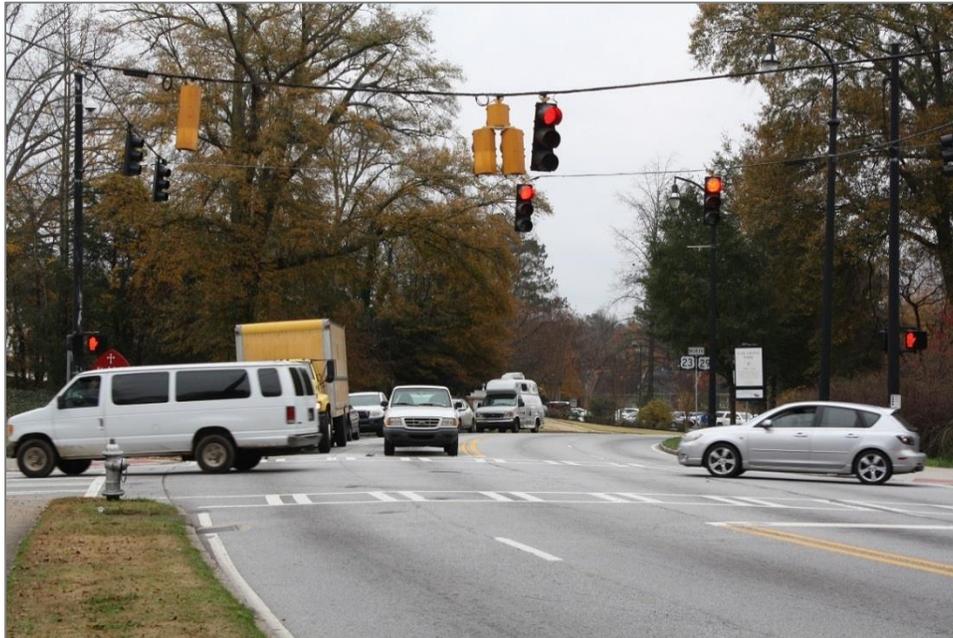
1. There are **no turn lanes** at this intersection.
2. The audit team observed **vehicles waiting to turn onto Oakdale Road** from westbound Ponce de Leon Avenue NE, causing traffic to back up.
3. There are several churches and a school located very near to this intersection. A **high level of pedestrian activity** is reported in this area.

FIGURE 5-24. INTERSECTION AT OAKDALE ROAD, LOOKING EAST.

SAFETY BENEFIT	LEVEL OF EFFORT	TIME FRAME	COST
1. Consider a recommendation from bicycle and pedestrian groups to raise the curb at intersection corners.	Moderate	Low	Intermediate	Low
2. Study opportunities to allow better turning movements from Ponce de Leon Avenue NE onto Oakdale Road and implement recommendations as appropriate.	High	High	Long Term	Moderate
3. Install a raised pedestrian crossing across Oakdale Road near St. John's Lutheran Church. This can serve as a traffic calming measure in addition to a pedestrian safety feature. <i>(Note: Ensure the raised crossing is fully in the City of Atlanta right-of-way).</i>	Moderate	Low	Intermediate	Low

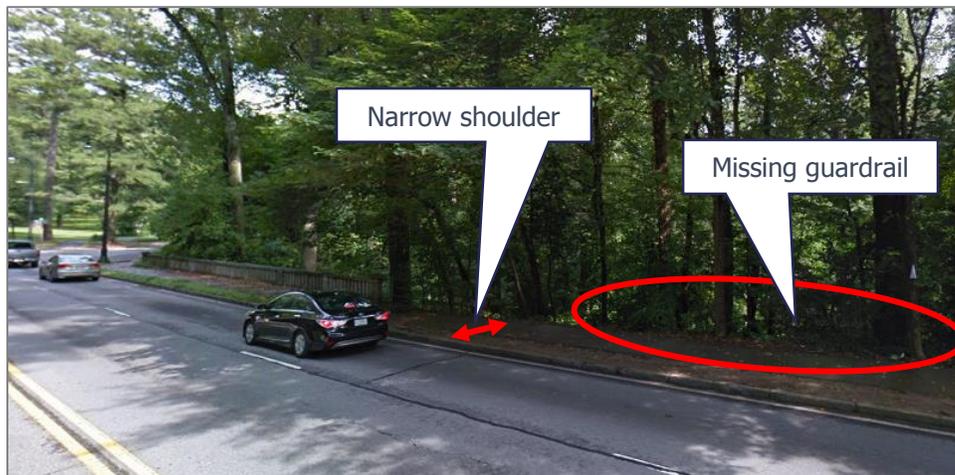
FIGURE 5-29. BRIDGE OVER LULLWATER CREEK EAST OF LULLWATER ROAD/FAIRVIEW ROAD.

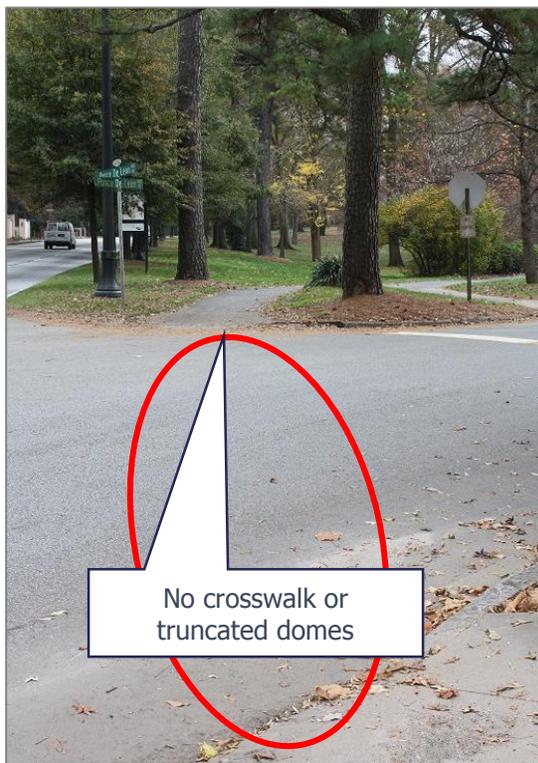
1. The PATH Foundation's Stone Mountain Trail meets with South Ponce de Leon Avenue near Lullwater Estate, connecting to the paths in Shady Side Park
2. The audit team observed **potential drainage issues** at this intersection.
3. A **fire hydrant** was found to be **out of service** near this intersection on the north side of the road (at approximately 1632 Ponce de Leon Avenue NE).
4. A **damaged school zone sign** was found on the north side of Ponce de Leon Avenue NE, near Lullwater Estate. This **sign is not needed** as this area is not currently a permitted school zone.
5. The **pavement markings and crosswalk** at Lullwater Road/Fairview Road are **worn and faded**.
6. **Visibility is limited** for drivers **turning left from South Ponce de Leon Avenue NE near Lullwater Estate** because of the angle of the road to Ponce de Leon Avenue NE.

FIGURE 5-31. THE WESTERN END OF THE SECOND SEGMENT OF SOUTH PONCE DE LEON AVENUE NE (NEAR LULLWATER ESTATE).

SAFETY BENEFIT	LEVEL OF EFFORT	TIME FRAME	COST
1. Remove damaged and incorrect school zone sign.	Low	Low	Short Term	Low
2. Coordinate with the Paideia School to permit school zone and sign appropriately.	Moderate	Low	Short Term	Low
3. Study the feasibility of expanding the shoulder or relocating the sidewalk farther from travel lanes at the bridge over the creek, west of South Ponce de Leon Avenue, and implement if possible.	High	Moderate	Long Term	High
4. Repair the fire hydrant.	Low	Low	Short Term	Low
5. Consider redesigning the intersection as right-in/right-out on South Ponce de Leon Avenue NE.	High	Moderate	Long Term	Moderate
6. Install bulb-out to T-off intersection and shorten pedestrian crossing.	High	Moderate	Intermediate	Moderate

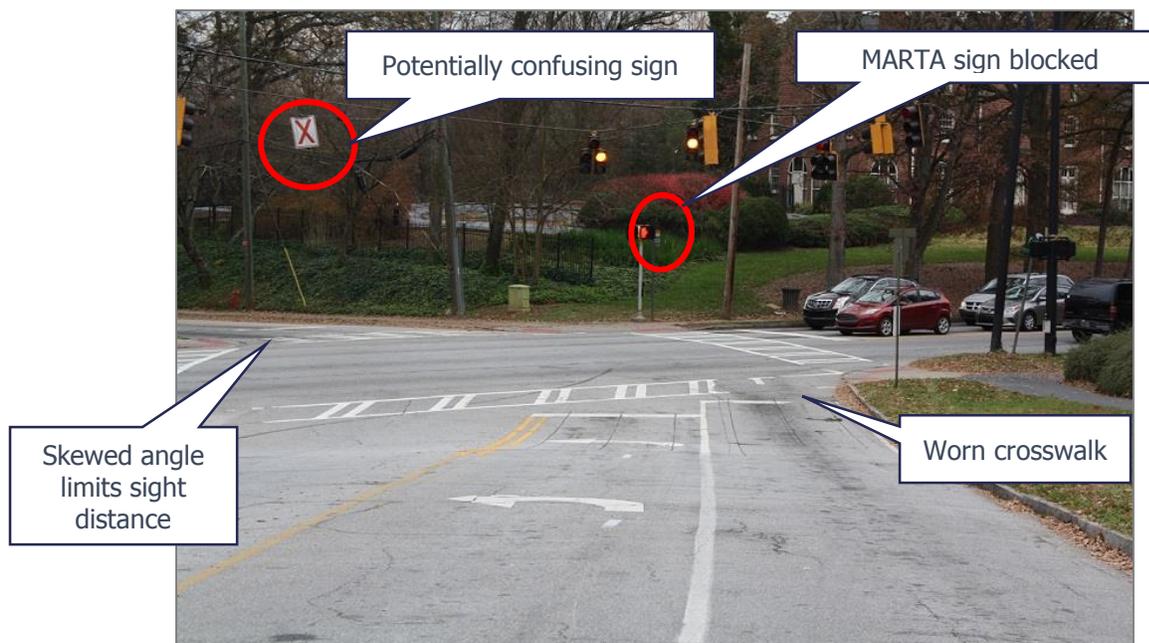
9. The intersection was not constructed in a manner consistent with Olmsted's original plan. The **skewed angle limits driver visibility** and may negatively impact safety.

FIGURE 5-34. CLIFTON ROAD LOOKING NORTH ACROSS PONCE DE LEON AVENUE NE.

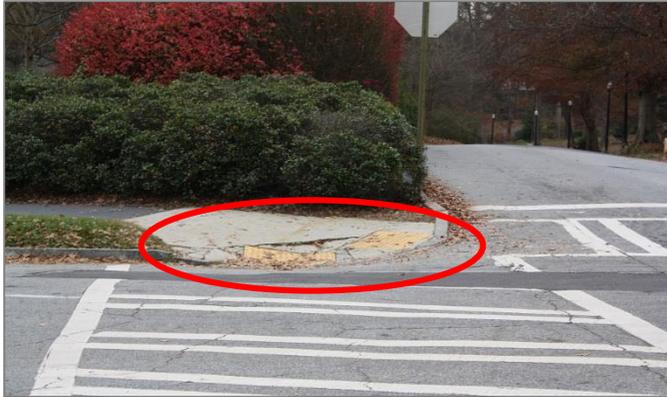
FIGURE 5-36. DAMAGED CURB RAMP AND TRUNCATED DOMES AT CLIFTON ROAD AND SOUTH PONCE DE LEON AVENUE.

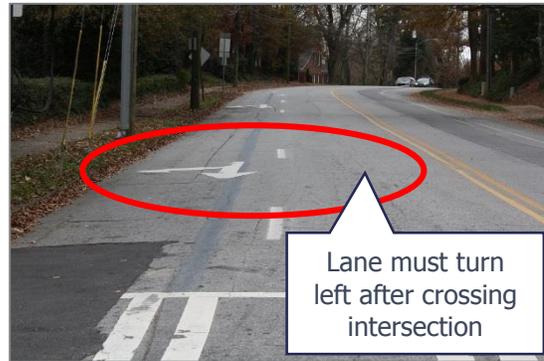
7. **Pavement markings and center line striping** on Clifton Road are **worn and faded** both north and south of the RSA corridor.
8. **Pavement markings in northbound lanes of Clifton Road** (south of Ponce de Leon Avenue NE) **may be confusing** to drivers as they crest the hills at South Ponce de Leon Avenue.

FIGURE 5-35. POTENTIALLY CONFUSING PAVEMENT MARKINGS ON CLIFTON ROAD (SOUTH OF SOUTH PONCE DE LEON AVENUE) DO NOT INDICATE THAT LEFT LANE MUST TURN LEFT ON PONCE DE LEON AVENUE NE AFTER CROSSING SOUTH PONCE DE LEON AVENUE.

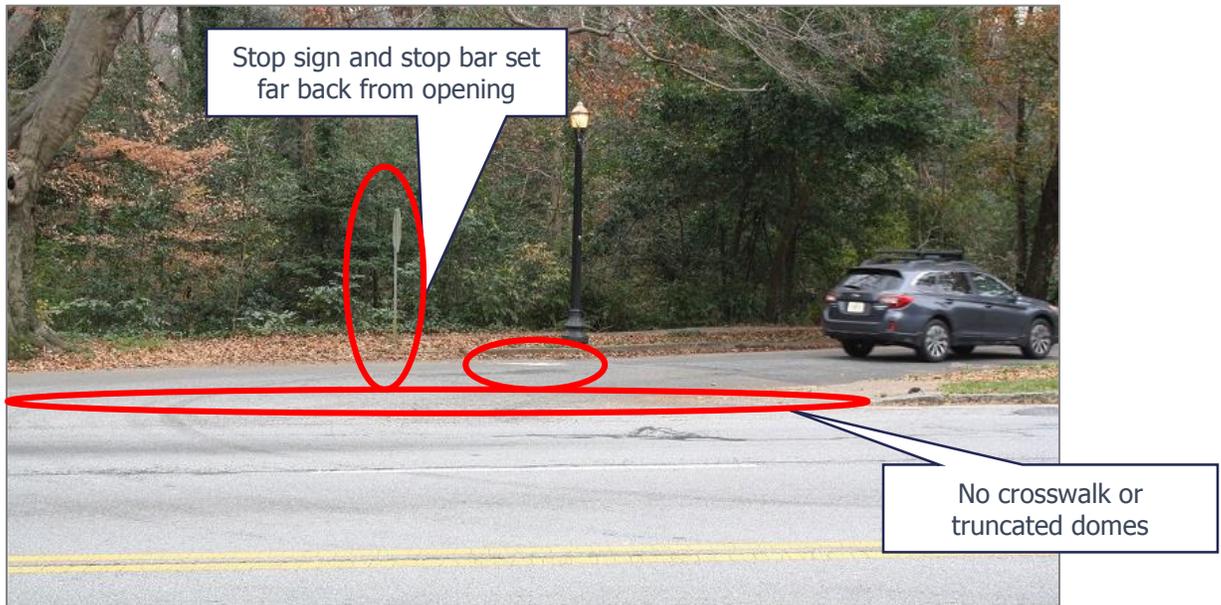
1. The **stop sign and stop bar at the east end** of South Ponce de Leon Avenue was **found to be too far back from Ponce de Leon Avenue.**
2. The intersection **at an angle to Ponce de Leon Avenue**, with a **wide opening** that makes for a long crossing for pedestrians.
3. Pedestrian facilities, including a crosswalk and truncated domes, are missing.

FIGURE 5-41. FAR EAST END OF SOUTH PONCE DE LEON AVENUE.

SAFETY BENEFIT	LEVEL OF EFFORT	TIME FRAME	COST
1. Install a bulb-out to square or T-off the intersection and shorten the pedestrian crossing distance.	High	Moderate	Intermediate	Moderate
2. Refresh and install pavement markings and lane striping as needed.	High	Low	Short Term	Low
3. Relocate stop bar and stop sign closer to intersection.	High	Low	Short Term	Low
4. Install pedestrian facilities including crosswalk and truncated domes.	High	Low	Short Term	Low

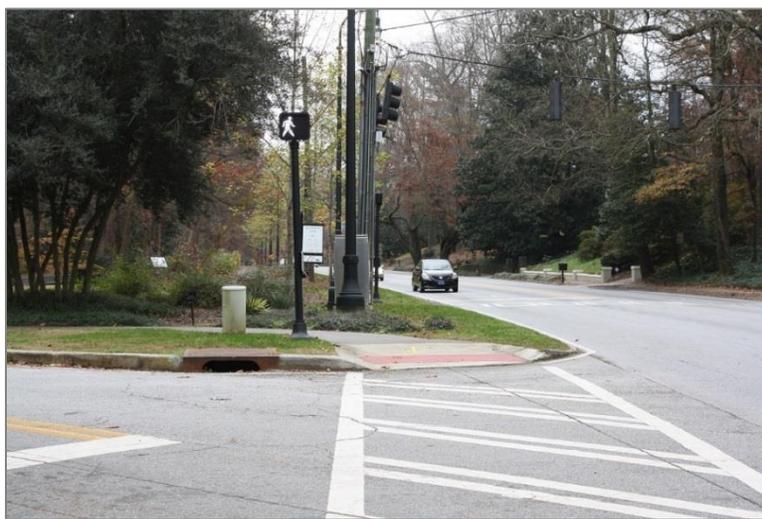
FIGURE 5-44. ENTRANCE TO DEEPDENE PARK AT NORTH PONCE DE LEON AVENUE NE.

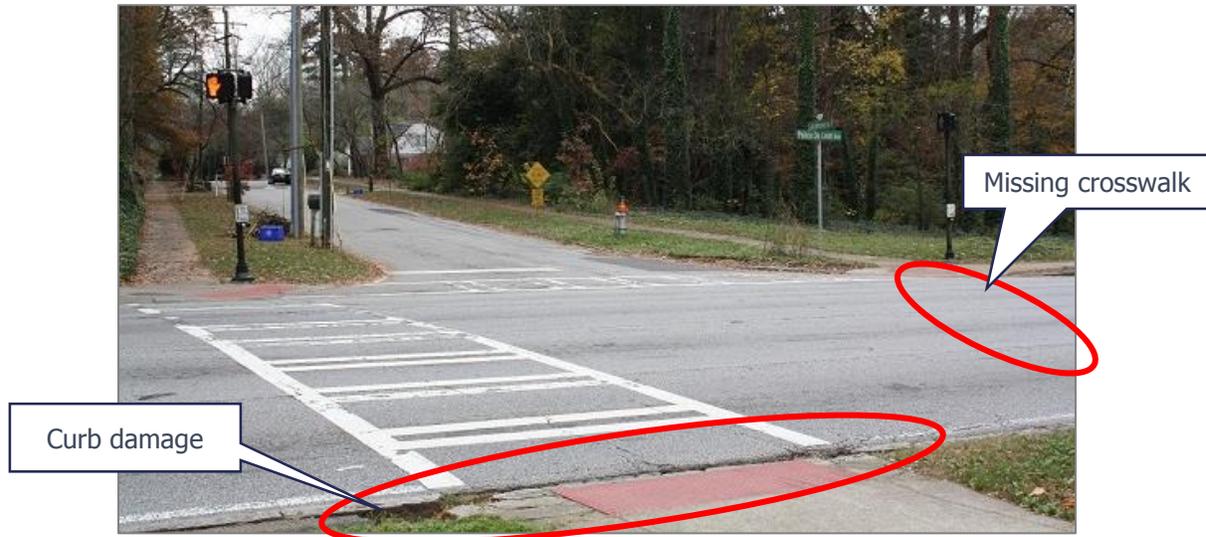
1. One of the **driveways to 1820 Ponce de Leon Avenue** has been closed off with asphalt and **does not conform to current standards**.
2. A **sinkhole** was observed alongside the sidewalk on the north side of Ponce de Leon Avenue NE near Lullwater Creek (west of North Ponce de Leon Avenue).
3. The audit team observed that a **proper guardrail is needed** on the north side of Ponce de Leon Avenue NE at the culvert between South Ponce de Leon Avenue and North Ponce de Leon Avenue.
4. The **two side streets**, North Ponce de Leon Avenue and Lakeshore Drive, are **offset** from one another and signals are programmed for split phases.

FIGURE 5-45. INTERSECTION AT LAKESHORE DRIVE.

SAFETY BENEFIT	LEVEL OF EFFORT	TIME FRAME	COST
1. Investigate the driveway at 1820 Ponce de Leon Avenue NE and bring into conformity as needed. Rebuild curb.	Low	Low	Short Term	Low
2. Install crosswalk on west leg of intersection.	High	Low	Short Term	Low
3. Investigate and repair the sinkhole as needed.	Moderate	Low	Intermediate	Moderate
4. Install a new guardrail on the north side of Ponce de Leon Avenue NE.	High	Low	Short Term	Low
5. Consider a recommendation from bicycle and pedestrian groups to raise the curb at intersection corners.	Moderate	Low	Intermediate	Low
6. Study the feasibility of tying the intersections at North Ponce de Leon Avenue and at Lakeshore Drive together with a new intersection design. Implement design recommendations if feasible.	High	High	Long Term	High

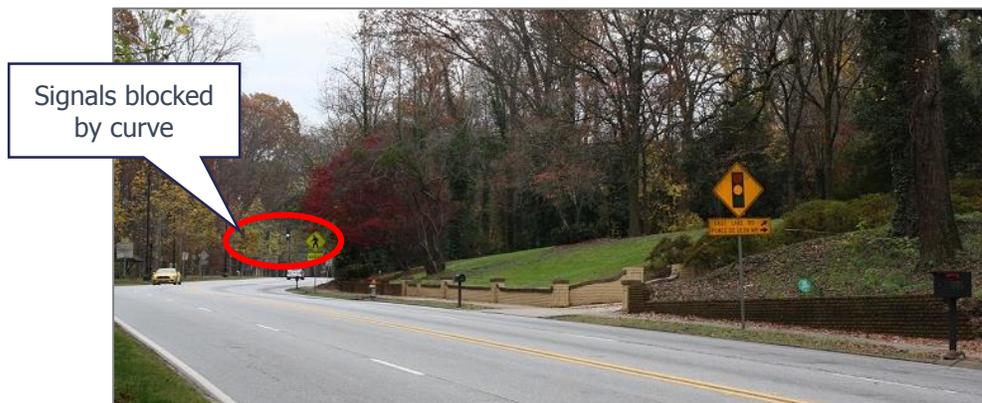
5. The intersection at Ponce de Leon Manor is very close to the one at East Lake Road. The **intersection at East Lake Road is very wide and potentially confusing** to drivers. The eastbound **right-hand lane** is very wide and was found to be **not clearly marked.** Directional signs were also found to be confusing at this intersection.

FIGURE 5-48. VIEW OF PONCE DE LEON AVENUE NE APPROACHING EAST LAKE ROAD FROM THE WEST.

SAFETY BENEFIT	LEVEL OF EFFORT	TIME FRAME	COST
1. Implement project to rehabilitate drainage facilities (PI #0010474).	High	Moderate	Intermediate	Moderate
2. Repair or install curb as needed near East Lake Road.	Moderate	Low	Intermediate	Moderate
3. Connect the pedestrian crosswalk at Ponce de Leon Manor with the multi-use trail in Deepdene Park.	Low	Low	Short Term	Low
4. Install a crosswalk on the east leg of the intersection with Ponce de Leon Manor.	High	Low	Short Term	Low
5. Consider altering the design or configuration of the intersection. Identify and carry out implementation steps as appropriate.	High	High	Long Term	High
6. Study the feasibility of redesigning the intersection as a roundabout.	High	High	Long Term	High

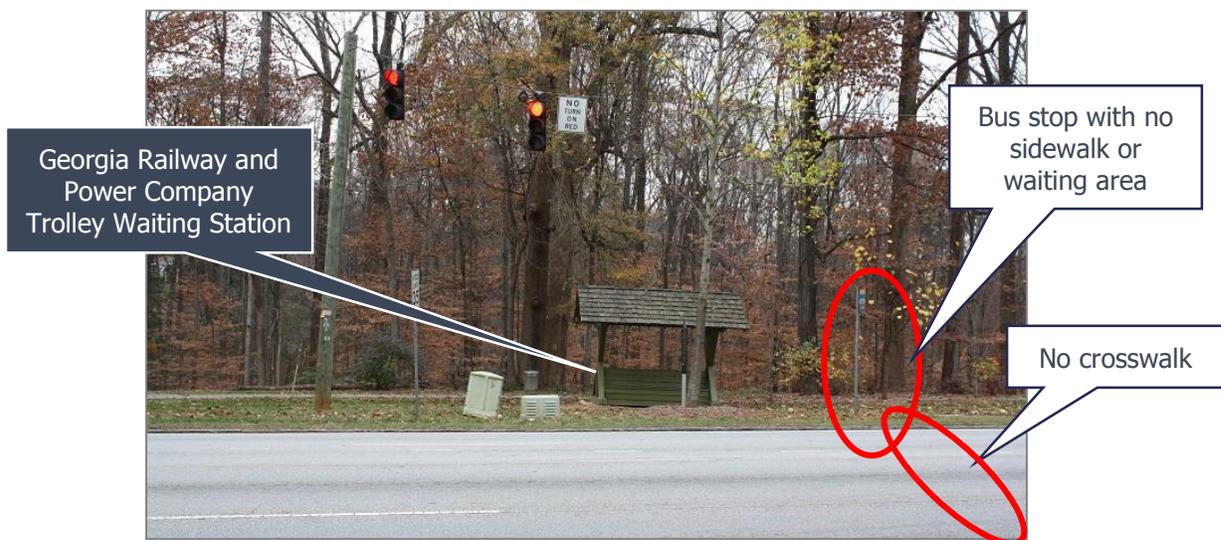
1. The audit team observed that the **curb is missing** along the south side of Ponce de Leon Avenue NE near East Lake Road.
2. The **pedestrian landing** on the north side of the RSA corridor **at the crosswalk** to Ponce de Leon Manor is **not connected to the multi-use trail** in Deepdene Park.

FIGURE 5-49. DEEPDENE PARK SEEN FROM PONCE DE LEON MANOR.

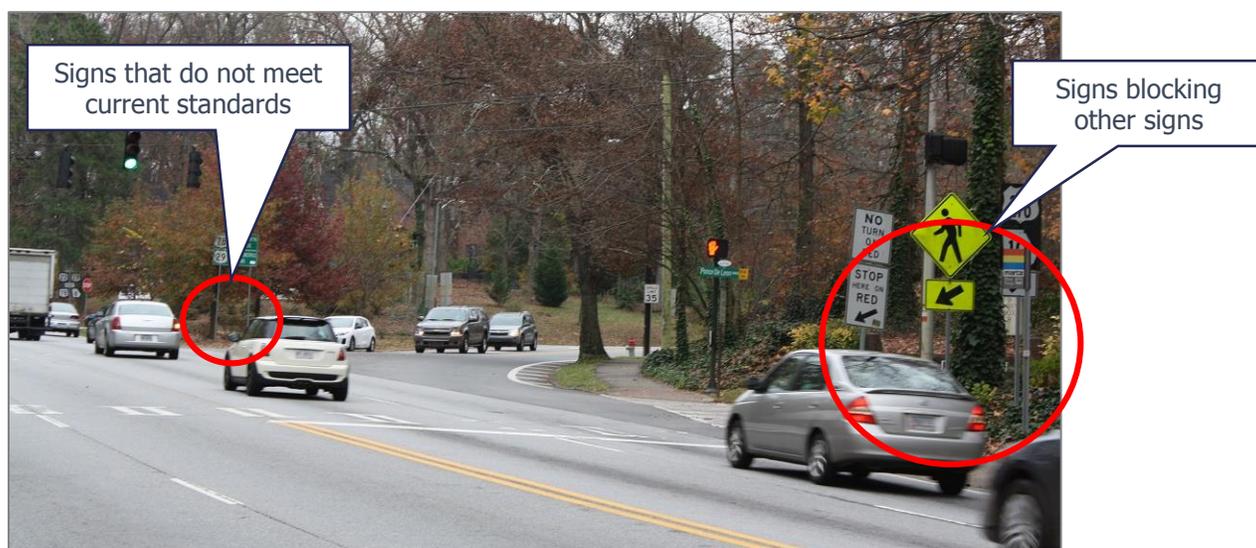
FIGURE 5-50. VIEW OF INTERSECTION AT EAST LAKE ROAD, LOOKING EAST PAST PONCE DE LEON MANOR.

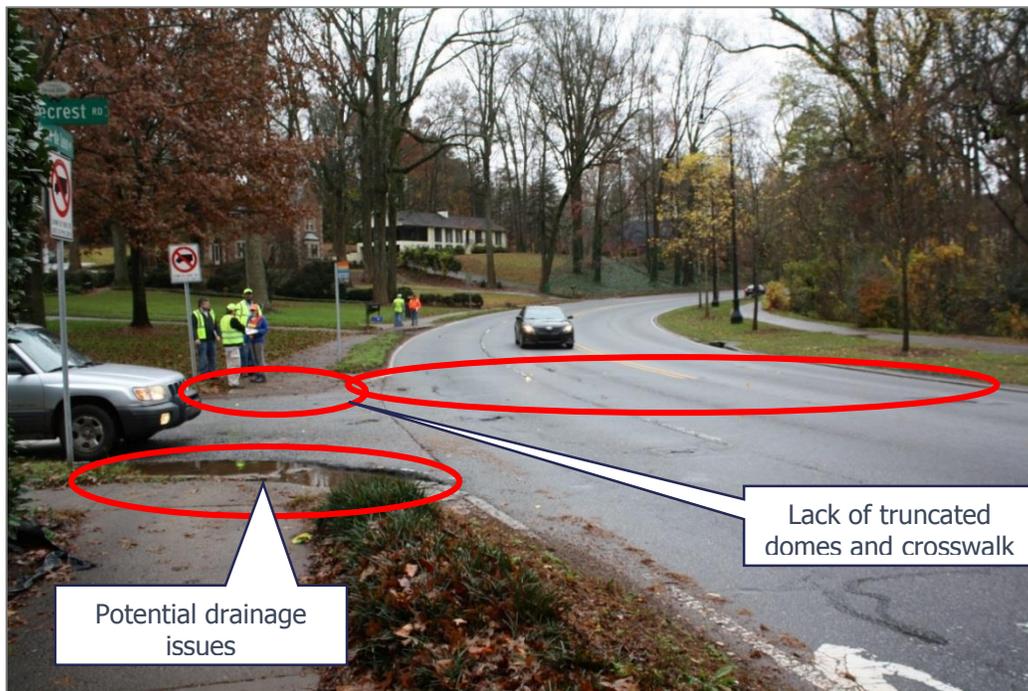
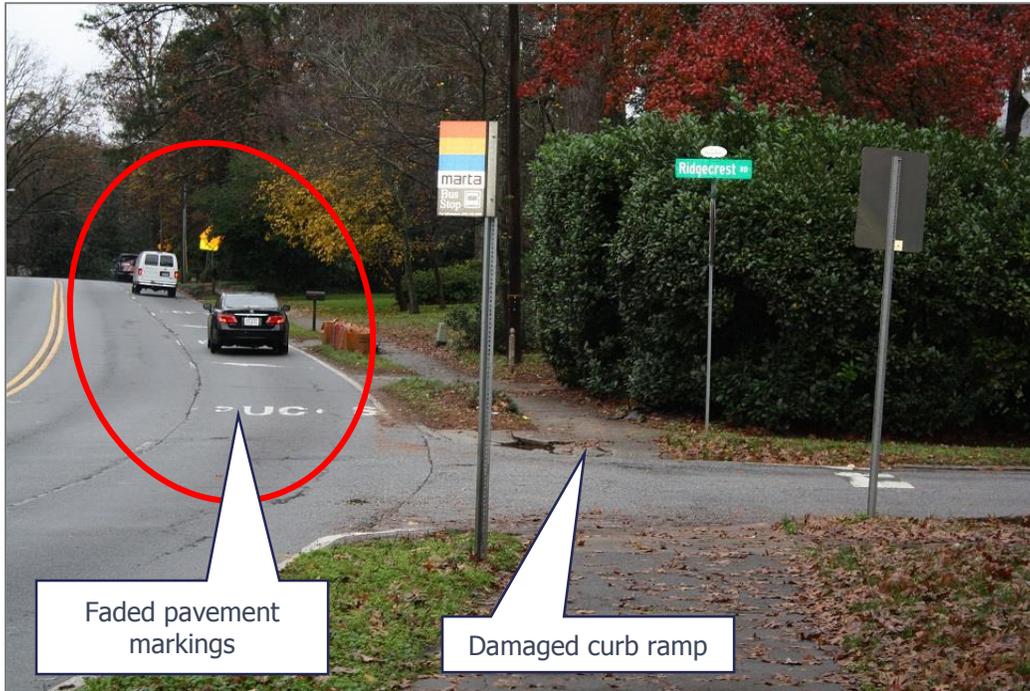
1. This is an **unsignalized** intersection.
2. The **double-wide driveway** at 2115 Ponce de Leon Avenue NE (near Ridgecrest Road) was observed to be in **disrepair** at the sidewalk and may have **potential drainage issues**.

3. The team observed **potential drainage issues at the intersection** of Ridgecrest Road. A former drain appeared to have been filled in and the curb ramp was flooded with standing water during the field inspection.

4. **Pedestrian ramps** were found to be **damaged** and at both corners of the intersection and truncated domes are missing.
5. The intersection is across the street from Deepdene Park and has a bus stop at the corner, yet there is **no crosswalk present**.

FIGURE 5-53. VIEW LOOKING WESTBOUND ACROSS RIDGECREST ROAD.

FIGURE 5-54. VIEW LOOKING EASTBOUND ACROSS RIDGECREST ROAD.

SAFETY BENEFIT	LEVEL OF EFFORT	TIME FRAME	COST
1. Investigate the driveway at 2115 Ponce de Leon Avenue NE and recommend or make repairs as needed.	Moderate	Low	Short Term	Low

2. Implement project to rehabilitate drainage facilities (PI #0010474).	High	Moderate	Intermediate	Moderate
3. Repair pedestrian ramps, install truncated domes, and bring pedestrian facilities into ADA compliance.	High	Low	Short Term	Low

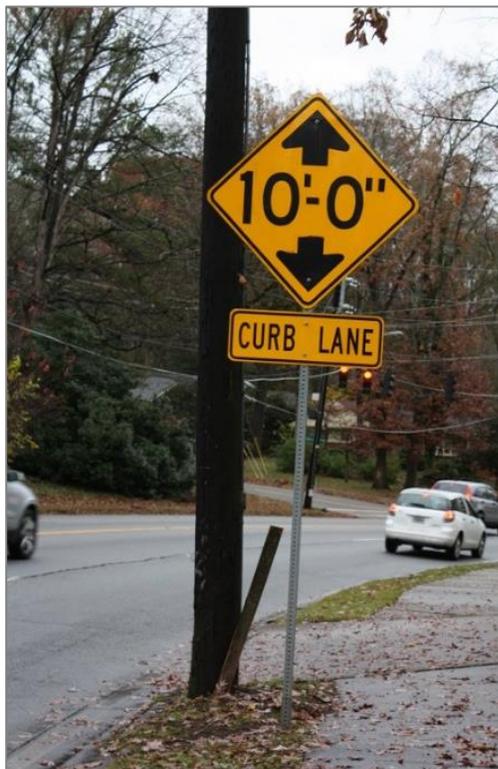
8. **Bridge clearance signage** (eastbound and westbound) is **not clear** and the team observed evidence of vehicles hitting the bridge overpass.
9. **Signage** approaching the railroad bridge from the west is **blocked by vegetation**.

FIGURE 5-56. UNCLEAR BRIDGE CLEARANCE SIGNAGE.

6. Refresh pavement markings.	High	Low	Short Term	Low
7. Replace bridge clearance signage approaching the bridge in both directions.	High	Low	Short Term	Low

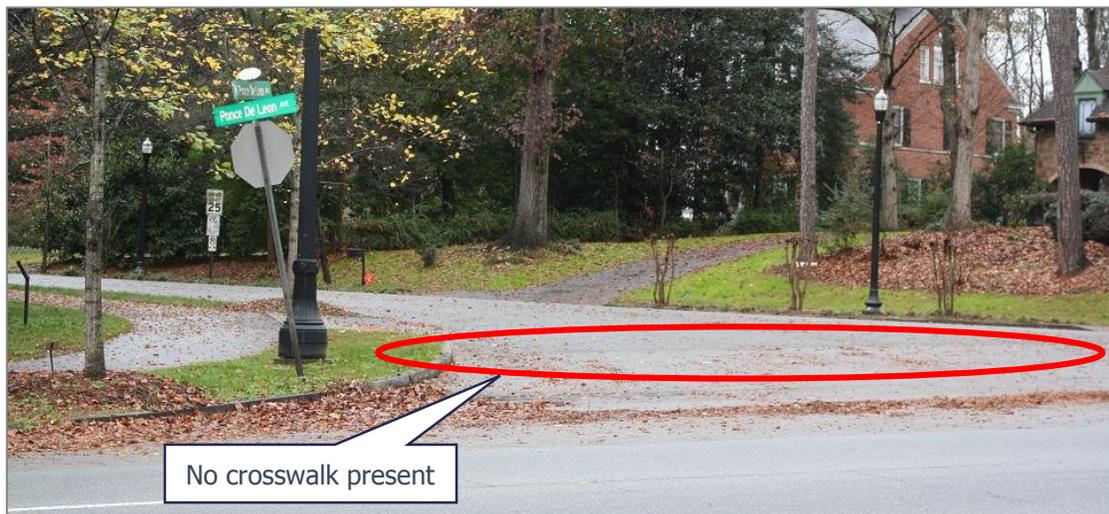
1. North Ponce de Leon Avenue is an **unsignalized** intersection in the middle of a curve along Ponce de Leon Avenue NE.
2. The opening of the intersection was found by the audit team to be very wide and it may not be clear where vehicles should travel in the intersection due to a **lack of pavement markings**.
3. There is **no crosswalk** across North Ponce de Leon Avenue.
4. The **pole** that has the **street name** and stop signs mounted on it was observed to be **tilted** and potentially damaged.

FIGURE 5-58. SOUTHWEST CORNER OF INTERSECTION AT THE EAST END OF NORTH PONCE DE LEON AVENUE.

SAFETY BENEFIT	LEVEL OF EFFORT	TIME FRAME	COST
1. Shorten the distance for pedestrians to cross North Ponce de Leon Avenue.	High	Moderate	Intermediate	Moderate
2. Study the feasibility of converting this intersection to a right-in/right-out only.	High	Low	Short Term	Low
3. Install new eight inch edge lines and/or raised pavement markers.	High	Low	Short Term	Low
4. Repair or replace sign pole as needed.	Moderate	Low	Short Term	Low
5. Study ways to reduce the width of the opening of the intersection such as constructing a bulb-out of the curb (into North Ponce de Leon Avenue) and additional landscaping. Implement recommendations as appropriate.	Moderate	Moderate	Intermediate	Low

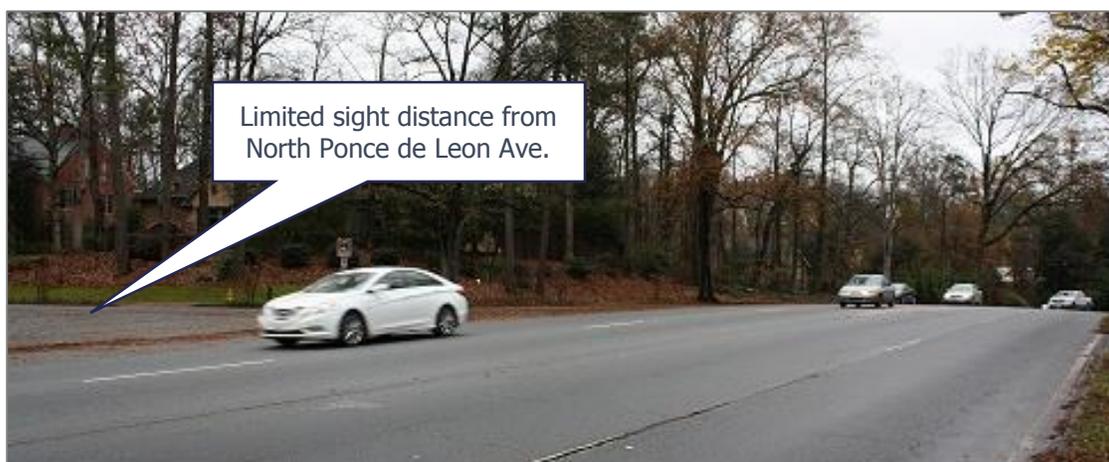
FIGURE 5-59. SOUTHBOUND TRAFFIC AT NORTH PONCE DE LEON AVENUE.

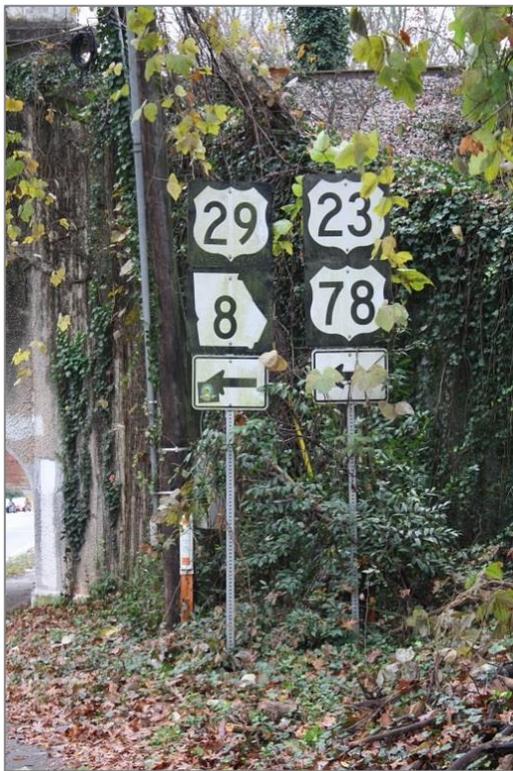
1. Artwood Road provides **access to Fernbank Elementary School**.
2. **Signage** approaching the bridge is **partially blocked by vegetation**.
3. The audit team observed **evidence of vehicles driving over the curb** onto the sidewalk as they round the curve approaching the railroad bridge.

FIGURE 5-62. EASTBOUND SIGNAGE PARTIALLY OBSCURED BY VEGETATION.

2. Investigate and repair or replace pedestrian countdown signal as needed.	High	Low	Short Term	Low
3. Trim vegetation to reduce sign blockage.	High	Low	Short Term	Low

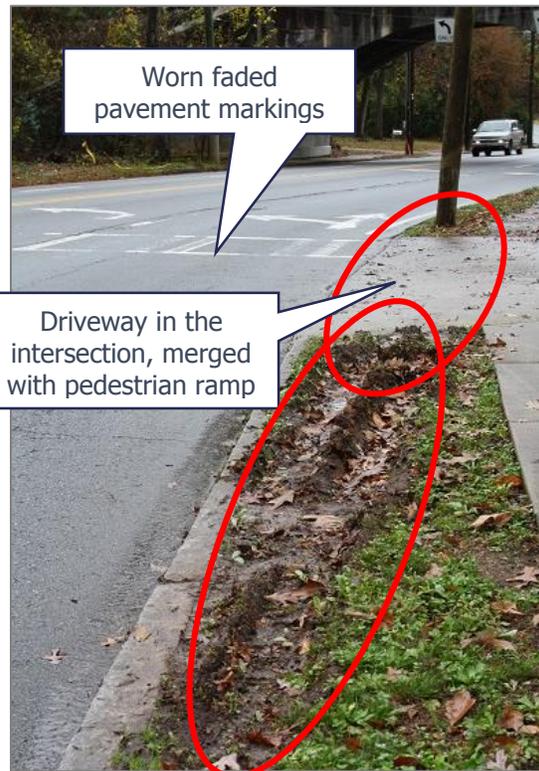
FIGURE 5-63. EVIDENCE OF VEHICLES DRIVING ON THE CURB AND SIDEWALK AS THEY ROUND THE CURVE.

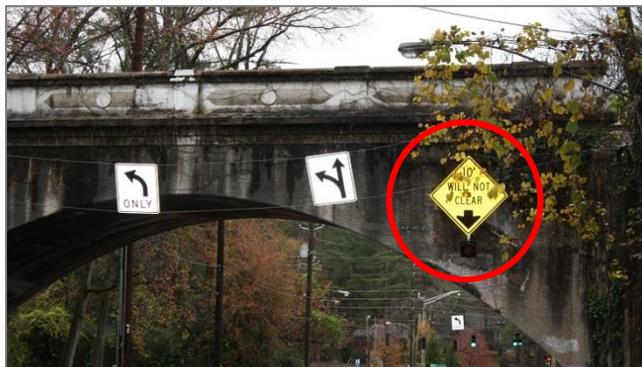
FIGURE 5-64. SIGNAGE IN EASTBOUND LANES BLOCKED BY VEGETATION.

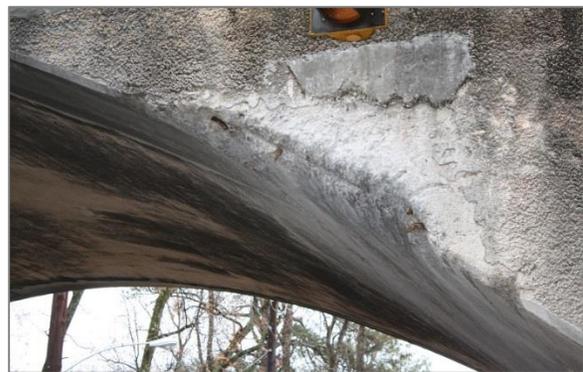
FIGURE 5-65. EVIDENCE OF VEHICLES HITTING BRIDGE OVERPASS.

10. Install new bridge clearance signage on the bridge and in advance of the bridge as appropriate.	High	Moderate	Short Term	Low

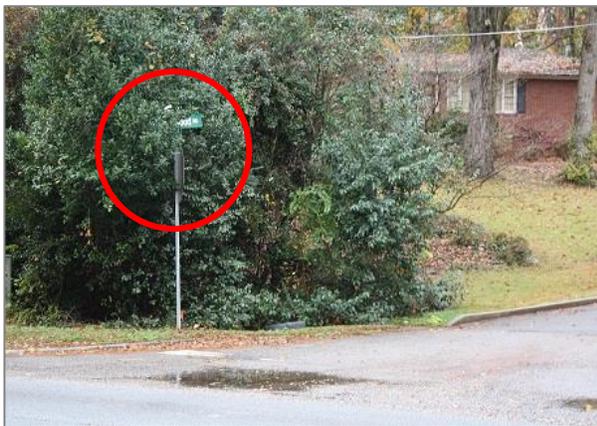
FIGURE 5-67. STREET NAME SIGN BLOCKED BY VEGETATION AT NORTH PARKWOOD ROAD.

SAFETY BENEFIT	LEVEL OF EFFORT	TIME FRAME	COST
1. Trim vegetation to make signs more visible.	High	Low	Short Term	Low
2. Replace or remove signs in triangular median as needed and consider installing an advance road name sign for West Ponce de Leon Avenue.	Moderate	Low	Short Term	Low
3. Install an advance signal warning sign for eastbound drivers.	High	Low	Short Term	Low
4. Install sidewalks in triangular median to facilitate safer pedestrian access.	High	Low	Short Term	Low
5. Install crosswalks across Scott Boulevard.	High	Low	Short Term	Low
6. Redesign the intersection to create an offset signalized intersection with all three streets.	High	High	Long Term	High

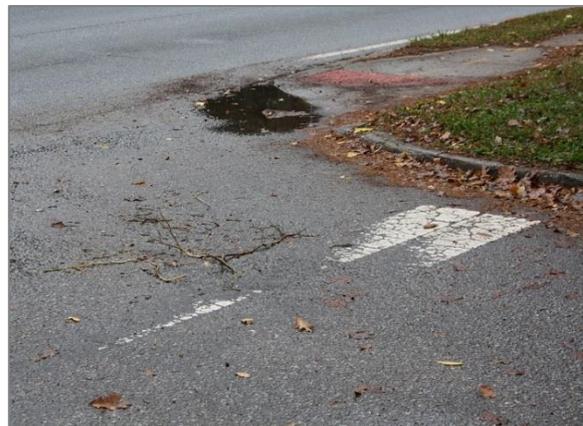
FIGURE 5-68. FADED STOP BAR AT NORTH PARKWOOD ROAD.

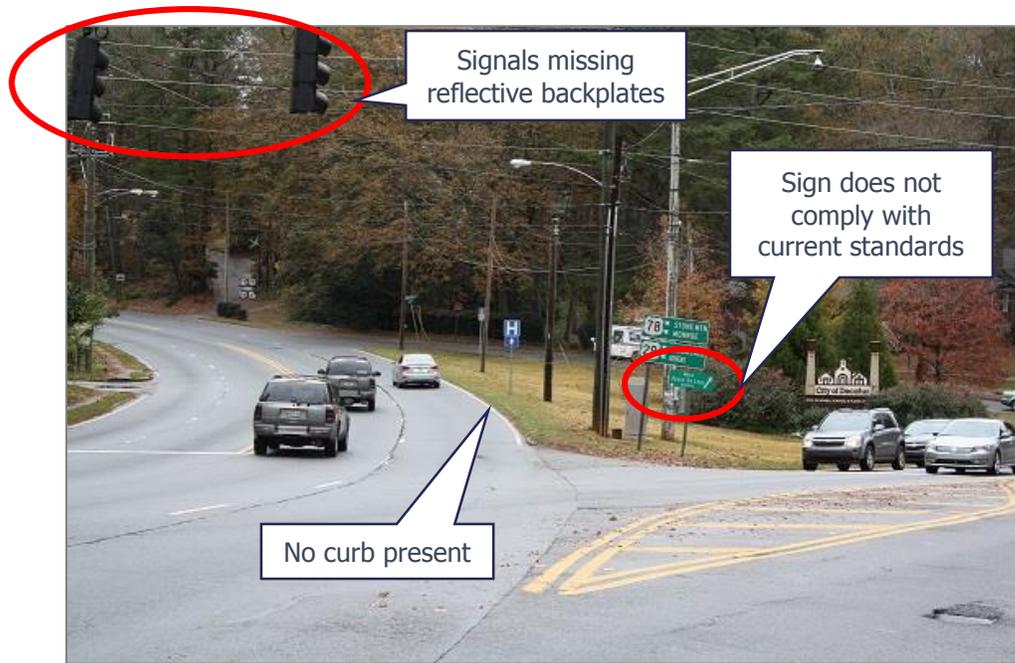
FIGURE 5-69. INTERSECTION AT WEST PONCE DE LEON AVENUE NE.
