CORRIDOR Road Safety Audit

SR 8 / SR 10 / US 23 / US 29 / US 78 / US 278 /
PONCE DE LEON AVENUE NE / SCOTT BOULEVARD
ATLANTA AND DECATUR | DEKALB COUNTY | GEORGIA

Prepared for the Georgia Department of Transportation

December 2015

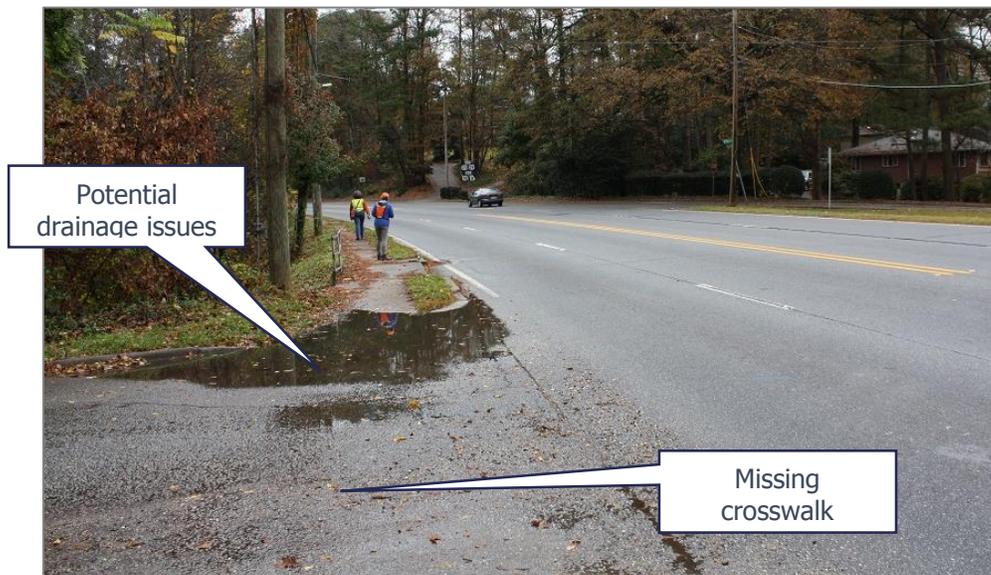
5. There is **no curb** along Scott Boulevard where the triangular median is located.
6. The audit team observed **potential sight distance issues**, particularly for vehicles turning off of North Parkwood Road onto the RSA corridor. North Parkwood Road is located in the middle of a curve. The angle at which East Parkwood Road intersects with the RSA corridor may also have potential sight distance issues, particularly for vehicles turning left.

FIGURE 5-70. VIEW OF SCOTT BOULEVARD AT NORTH PARKWOOD ROAD ILLUSTRATES LIMITED SIGHT DISTANCE.

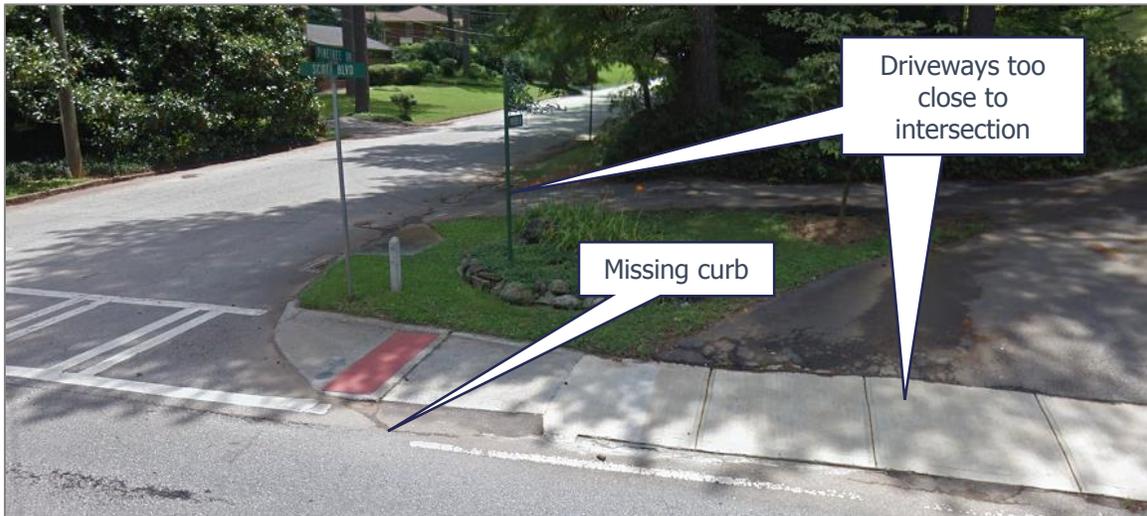
1. There is **no curb on the south side of the intersection.**
2. There are **two driveways** very **close to the intersection** – one on Pinetree Drive and one on Scott Boulevard.

FIGURE 5-74. DRIVEWAY AT CORNERS OF PINETREE DRIVE.

SAFETY BENEFIT	LEVEL OF EFFORT	TIME FRAME	COST
1. Repair or install a new curb where needed.	Moderate	Low	Short Term	Low

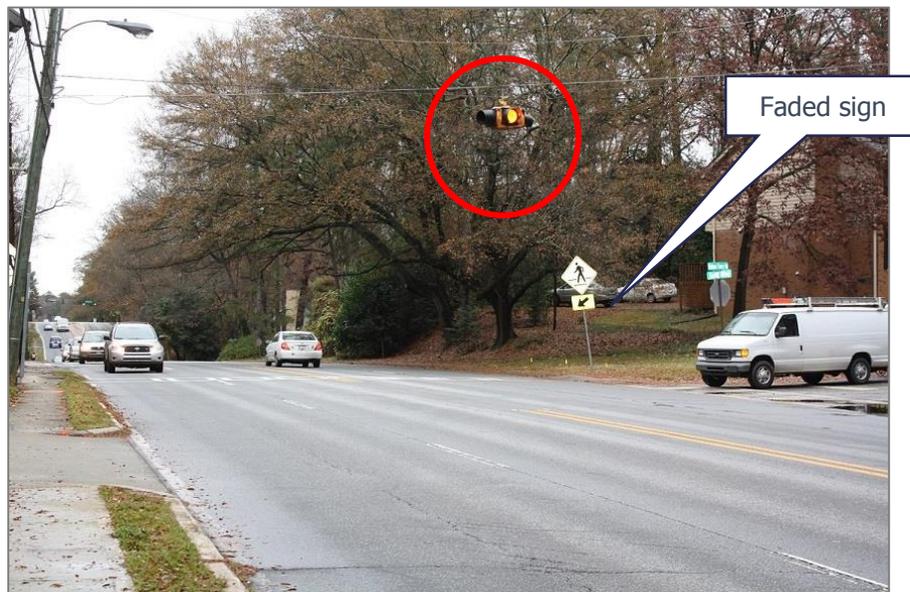
1. The intersection has an **overhead flashing yellow beacon**.
2. There is **only a crosswalk present on one leg of the intersection** (on the north side of Nelson Ferry Road).
3. The **pedestrian signs** were observed by the audit team to be **worn and faded**.
4. The audit team observed **potential drainage issues** and cracked pavement at or near the intersection.

FIGURE 5-75. OVERHEAD FLASHING BEACON AT NELSON FERRY ROAD

SAFETY BENEFIT	LEVEL OF EFFORT	TIME FRAME	COST
1. Consider removing or changing the flashing signal to a Pedestrian Hybrid Beacon (PHB) or Rapid Flash Beacon (RFB).	High	Moderate	Intermediate	Moderate
2. Investigate and repair drainage issues as needed.	High	Low	Short Term	Low
3. Install "Stop for Pedestrian" signs.	High	Low	Short Term	Low
4. Install a street name sign.	High	Low	Short Term	Low
5. Consider installing a "medianette" to facilitate safer pedestrian crossing.	High	High	Intermediate	Moderate

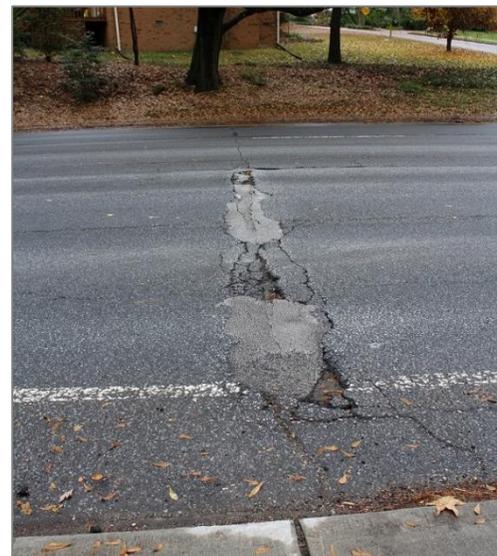
FIGURE 5-77. CRACKED PAVEMENT JUST NORTH OF NELSON FERRY ROAD.

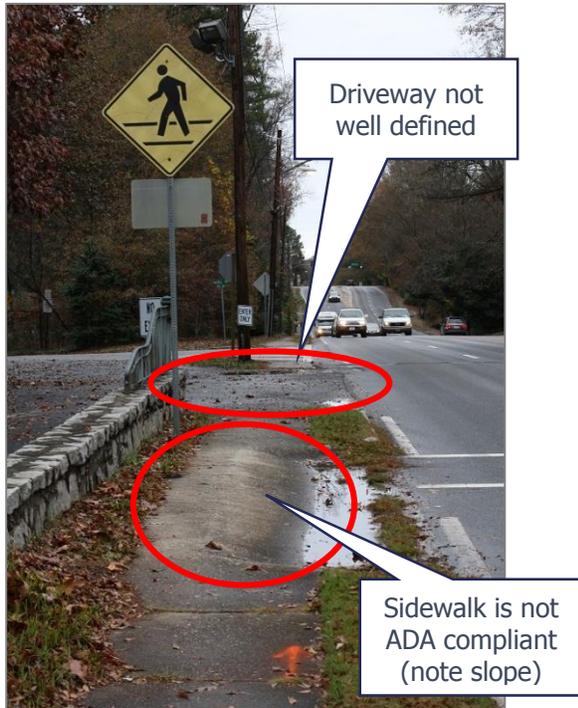
1. Merrill Avenue is at a **skewed angle** to the RSA corridor and this angle may cause sight distance and visibility issues.
2. The **driveway** at Venetian Pools (between Nelson Ferry Road and Merrill Avenue) is **not well defined**.
3. The **southwest quadrant is missing truncated domes**.

FIGURE 5-79. WEST SIDE OF SCOTT BOULEVARD (LOOKING NORTH) IN FRONT OF VENETIAN POOLS.

SAFETY BENEFIT	LEVEL OF EFFORT	TIME FRAME	COST
1. Better define the driveway at Venetian Pools and ensure pedestrian safety crossing the driveway.	High	Moderate	Intermediate	Low
2. Study ways to reduce the skew angle at Merrill Avenue and provide better sight distance. Implement feasible recommendations as appropriate.	Moderate	Low	Intermediate	Low

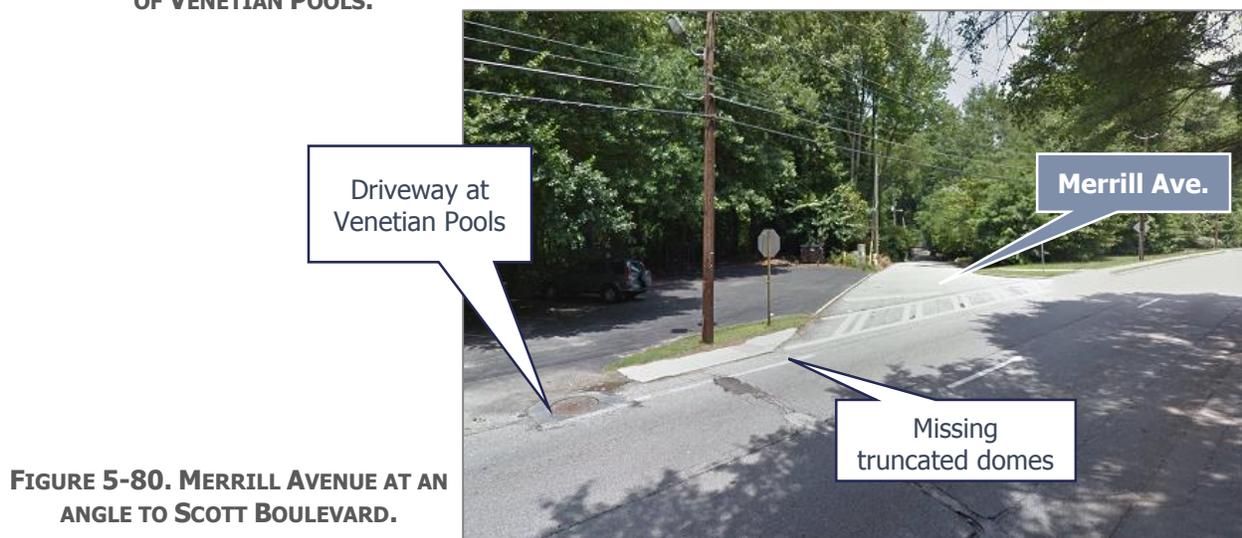
FIGURE 5-80. MERRILL AVENUE AT AN ANGLE TO SCOTT BOULEVARD.

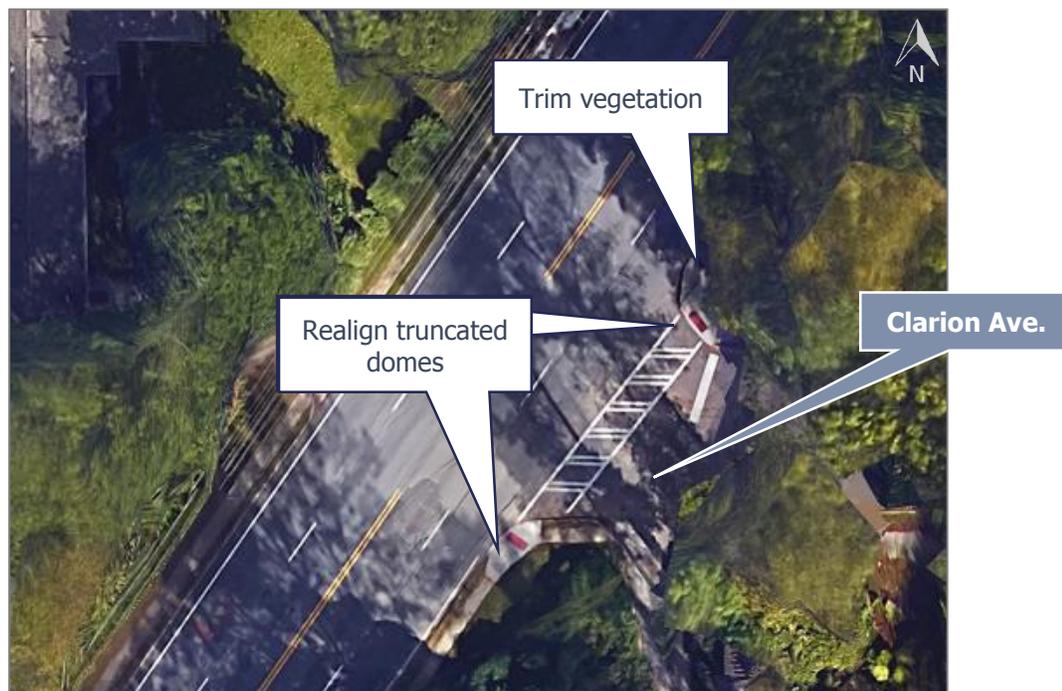
1. The audit team observed that the **curb ramp and truncated domes** in the southeast quadrant are **not aligned at an appropriate angle to the crosswalk**. The curb ramp is angled toward Scott Boulevard rather than across Clarion Avenue and the truncated domes are set too far back from the ramp edge.
2. The **street name sign** is **partially blocked** by vegetation.
3. The audit team observed **potential pavement condition and drainage issues** in the northeast quadrant of the intersection.

FIGURE 5-82. SUGGESTED IMPROVEMENTS FOR CLARION AVENUE.

SAFETY BENEFIT	LEVEL OF EFFORT	TIME FRAME	COST
1. Realign the curb ramp and truncated domes to create a safer pedestrian crossing across Clarion Avenue.	Moderate	Low	Short Term	Low
2. Trim vegetation around street name sign.	Moderate	Low	Short Term	Low
3. Investigate pavement condition and drainage issues and implement solutions as appropriate.	Moderate	Low	Short Term	Low

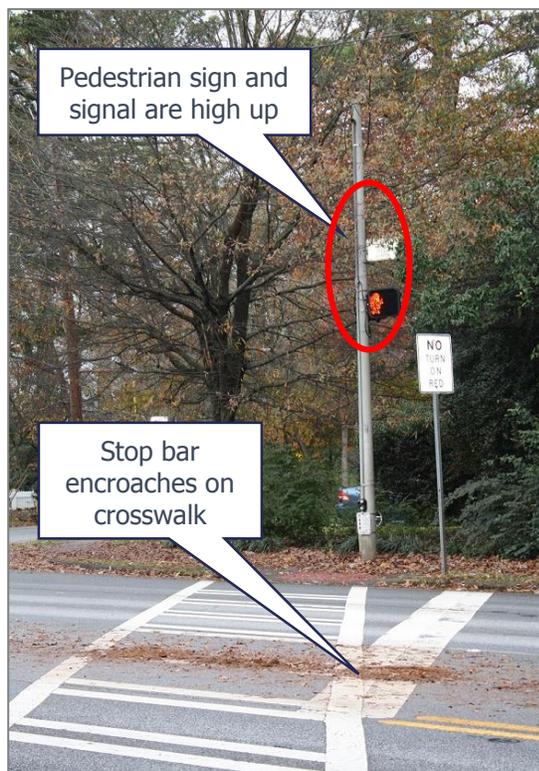
1. The **pedestrian signals and signs are located high** on poles and were observed by the audit team to be **partially obscured by vegetation**.
2. The audit team observed a **driveway in the northwest corner** of the intersection.

FIGURE 5-85. PEDESTRIAN CROSSING AT COVENTRY ROAD.

SAFETY BENEFIT	LEVEL OF EFFORT	TIME FRAME	COST
1. Replace or reposition pedestrian signs and signals so they are more visible to pedestrians.	Moderate	Low	Short Term	Low

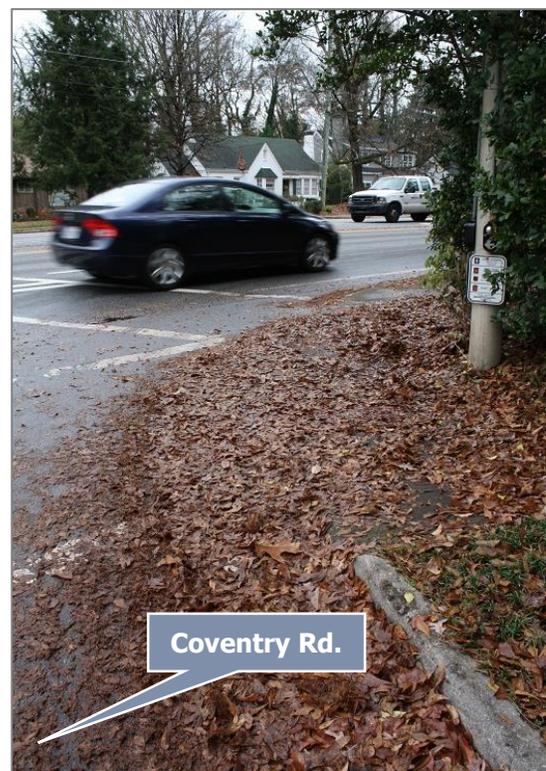
3. **Debris** was observed **covering the pedestrian ramps** and truncated domes in the northeast quadrant of the intersection.
4. The **stop bar** on the south leg of the intersection **overlaps with the crosswalk**.

FIGURE 5-84. DEBRIS BLOCKS PEDESTRIAN RAMP AT COVENTRY ROAD.

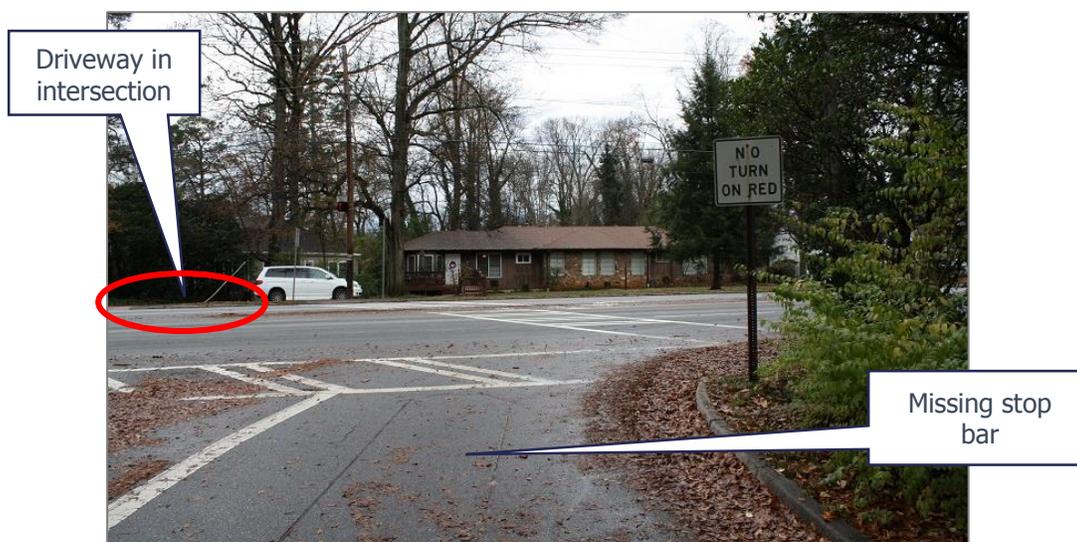
5. There are **painted islands** in the northeast and southwest quadrants of the intersection and a yield sign in the southwest quadrant.
6. The audit team observed "No Turn on Red" signs in three of the four approaches of the intersection (**there is not a "No Turn on Red" sign in the southwest quadrant**).

FIGURE 5-86. VIEW FROM NORTHEAST QUADRANT AT COVENTRY ROAD AND SCOTT BOULEVARD.

4. Remove painted islands.	Moderate	Low	Short Term	Low
5. Restripe stop bar and/or crosswalk so they no longer overlap.	High	Low	Short Term	Low
6. Consider a recommendation from bicycle and pedestrian groups to raise the curb at intersection corners.	Moderate	Low	Intermediate	Low

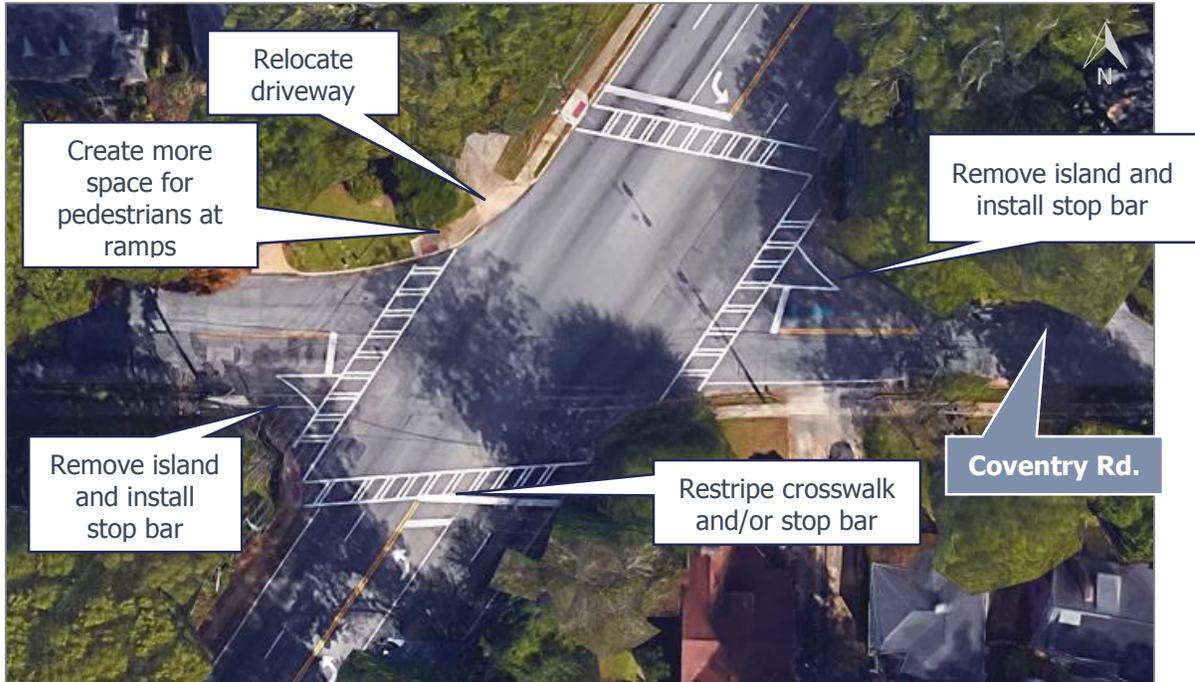
7. A **quick-response project** is planned for this intersection to **square off the approaches and improve pedestrian crossing**.
8. **Potholes** were observed near Coventry Road.

FIGURE 5-87. SUGGESTED IMPROVEMENTS TO INTERSECTION AT COVENTRY ROAD.

10. Carry out the planned quick-response project to square off the intersection approaches.	High	Moderate	Intermediate	Moderate

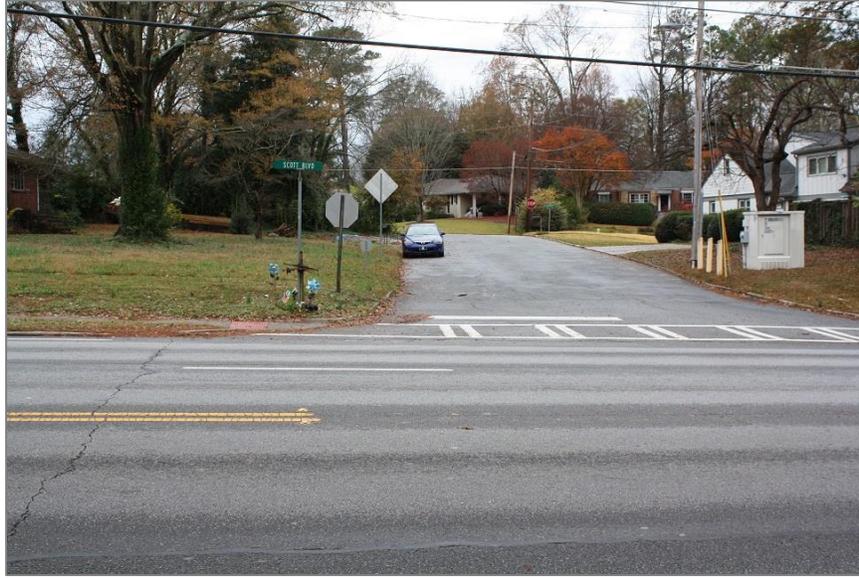
1. A fatal **crash occurred at Ridley Circle in 2015.**
2. The **sidewalk** on the east side of Scott Boulevard north of Garden Lane is **directly next to the road** (no separation between sidewalk and travel lanes).

FIGURE 5-89. VIEW OF INTERSECTION AT RIDLEY CIRCLE.

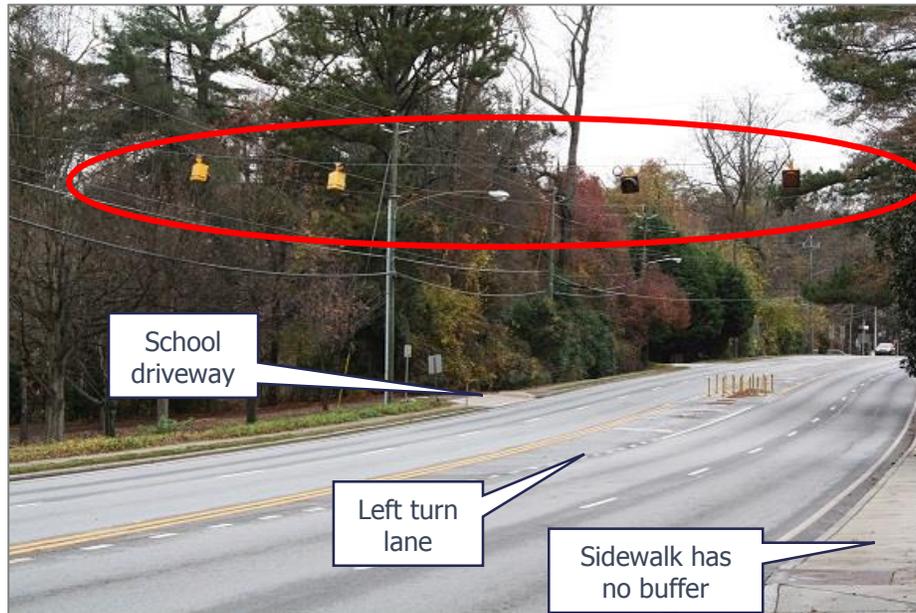
1. There is a set of **overhead flashing yellow signals** across Scott Boulevard directly in front of the school.
2. There is a **left turn lane into Westchester Elementary School** from northbound Scott Boulevard.

FIGURE 5-90. FLASHING OVERHEAD LIGHTS AND LEFT TURN LANE AT WESTCHESTER ELEMENTARY SCHOOL.

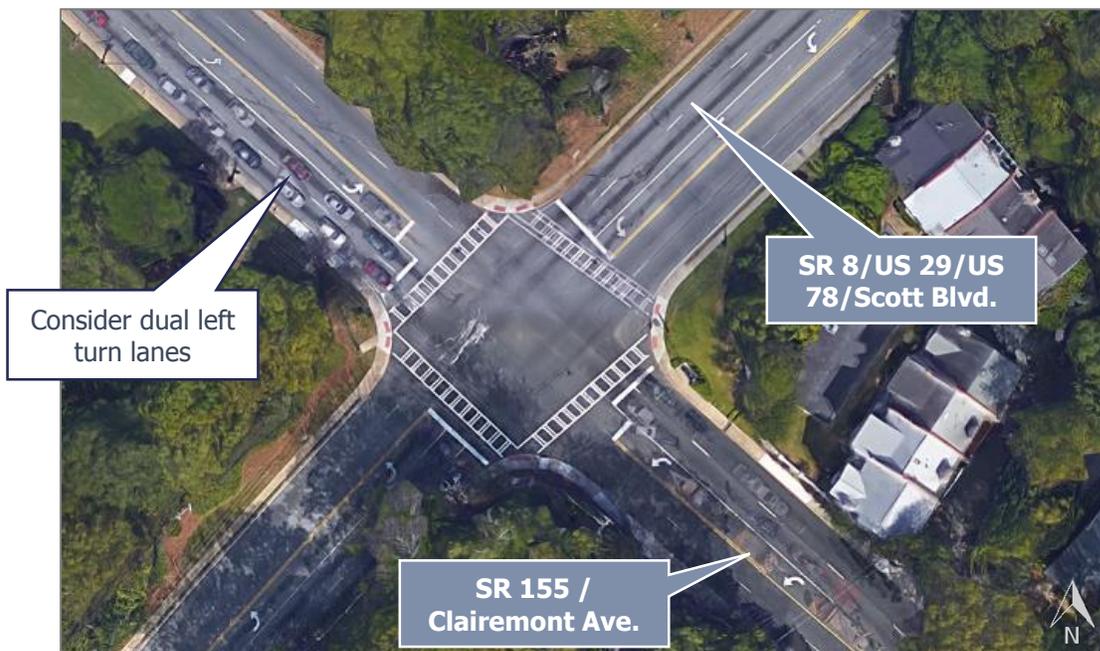
1. The audit team observed **water pooling and potential drainage issues** in the northeast quadrant of the intersection.
2. The intersection was **recently restriped** and had **new pedestrian facilities** installed as part of an improvement project on SR 155/Clairemont Avenue.
3. The audit team observed **vehicles backing up waiting to turn** at the intersection.

FIGURE 5-91. SUGGESTED IMPROVEMENTS FOR SR 155/CLAIREMONT AVENUE.

SAFETY BENEFIT	LEVEL OF EFFORT	TIME FRAME	COST
1. Study the need for and install dual left turns and implement recommendations as appropriate.	High	High	Long Term	High

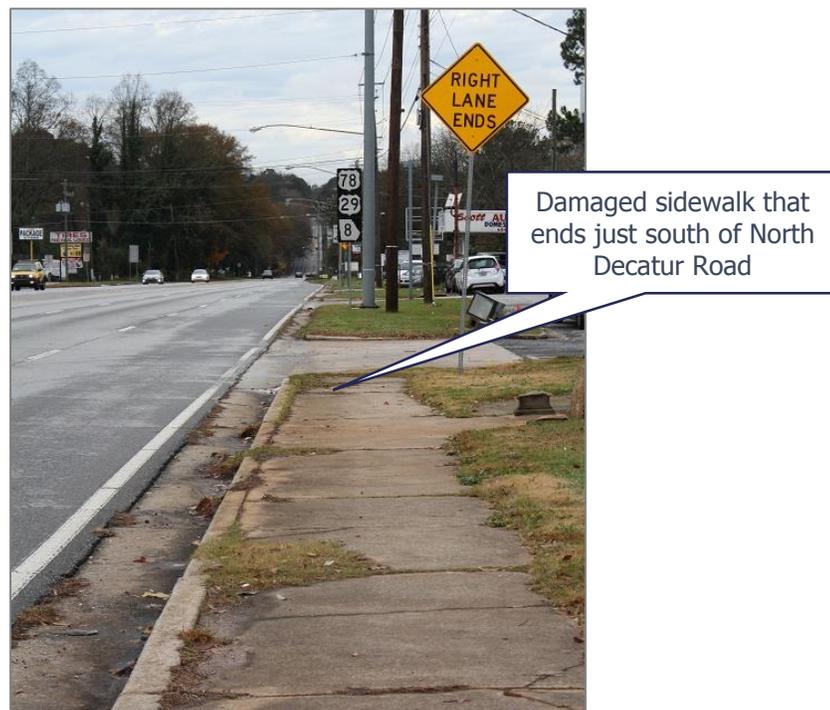
3. North of Eastland Drive, **SR 8/US 29/US 78/Scott Boulevard widens to six and then to seven lanes**.
4. The intersection with North Decatur Road, SR 8/US 29/US 78/Scott Boulevard, and Medlock Road is a **six-way intersection**. The audit team observed that **pedestrians are always in conflict with traffic**, even in the approaches with pedestrian crossing signals.

FIGURE 5-92. VIEW OF SOUTHBOUND SCOTT BOULEVARD FROM NORTH DECATUR ROAD.

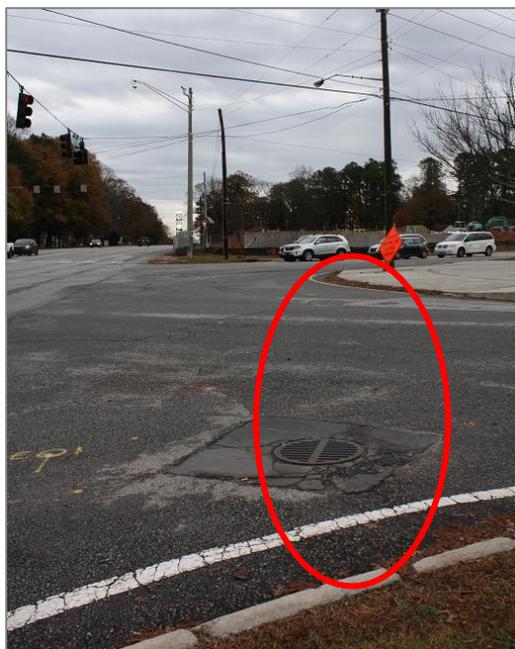
5. A **roundabout was studied** for this six-way intersection, but the study concluded that a roundabout is **not feasible** at this location.
6. There is **no pedestrian signal head or pedestrian crossing phase across Medlock Road**.

FIGURE 5-93. (LEFT) MISSING PEDESTRIAN FACILITIES AT MEDLOCK ROAD AND NORTH DECATUR ROAD.

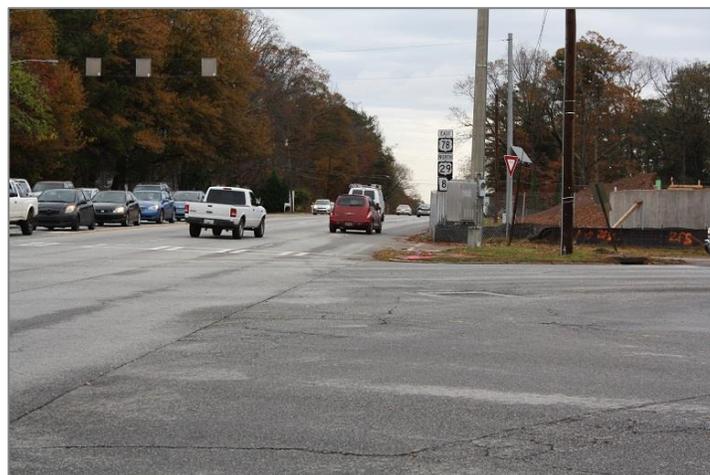
7. The middle segment of the intersection on the east side (north of North Decatur Road and south of SR 8/US 29) is the **site of the proposed Decatur Crossing mixed use development**.

FIGURE 5-94. (ABOVE) SITE OF FUTURE DECATUR CROSSING DEVELOPMENT AT RSA CORRIDOR AND NORTH DECATUR AND MEDLOCK ROADS.

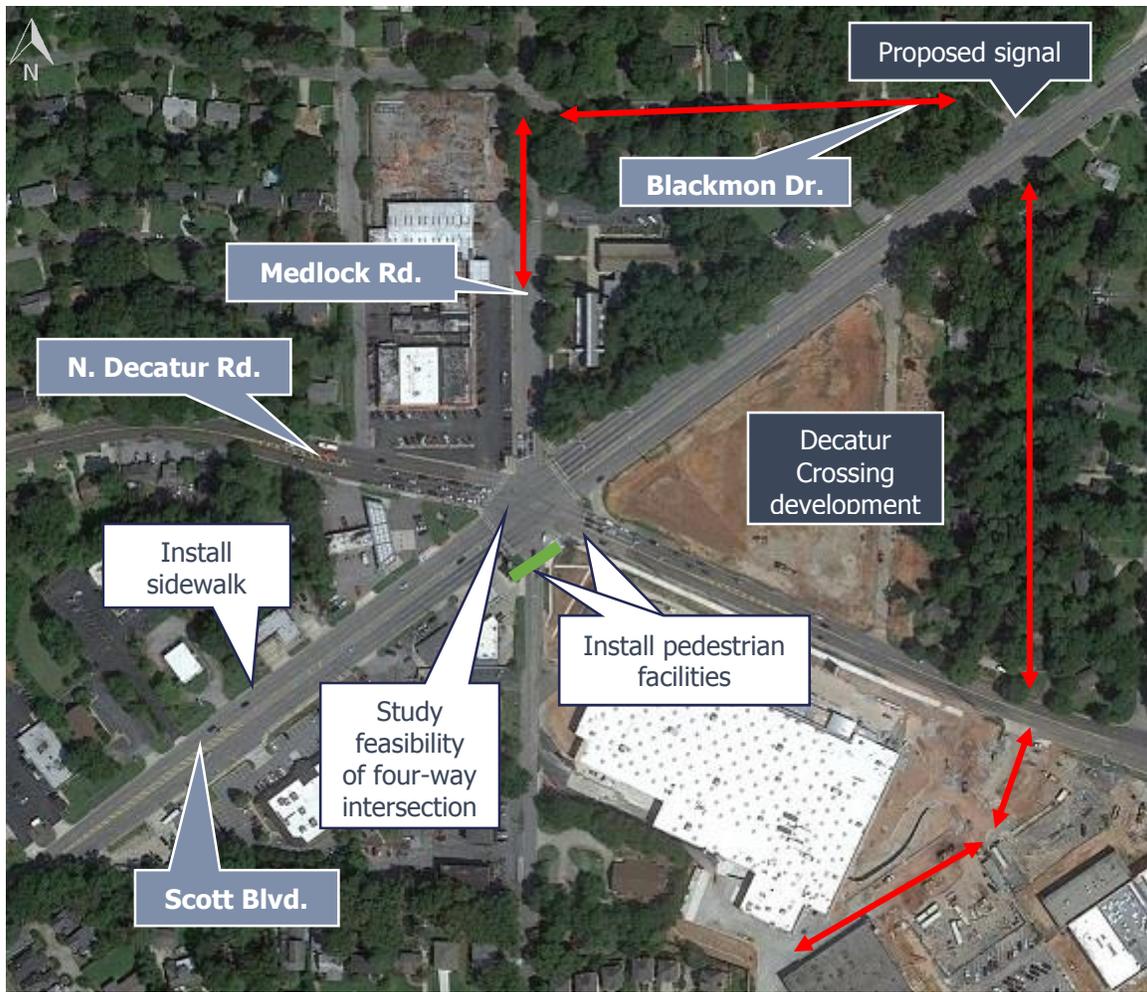
FIGURE 5-95. SUGGESTED IMPROVEMENTS FOR THE INTERSECTION AT MEDLOCK ROAD, NORTH DECATUR ROAD, AND SCOTT BOULEVARD. DIAGRAM ILLUSTRATES PROPOSED TRAFFIC PATTERNS, INCLUDING FOUR-WAY INTERSECTION AT BLACKMON DRIVE AND SCOTT BOULEVARD.

5. Study alternative configurations to improve safety. One option might be to reroute traffic from Medlock Road to Blackmon Drive and Vivian Circle and create a four-way intersection.	High	High	Long Term	High

6. Consider fully signaling the proposed traffic signal at Scott Boulevard and Blackmon Drive.	High	High	Long Term	Moderate
